Maes Merddyn, Brynsiencyn- Proposed Residential
Development:
Arboricultural Planning Assessment
(BS5837:2012)

Project no: WAL_24_030_P01

Date: 22nd November 2024

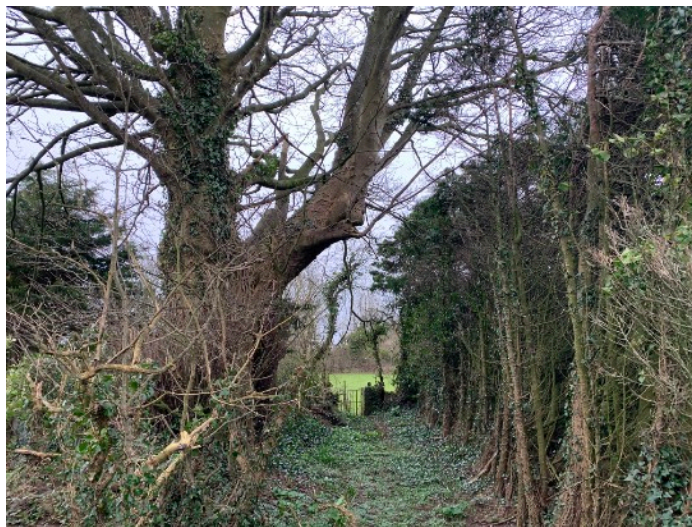
Fig 2. Large sycamore T8, off-site

T6	Sycamore	M	13	1030	12.36	480	0	4-6-5-7	Moderate vitality. Major dead wood. Poor form. Ivy on tree. Stem divides above 1.5m. OFFSITE.	Remove tree	<10	C1
T7	Sycamore	LM	23	990	11.88	443.44	0	12-6-13-9	Moderate vitality. Minor dead wood. Stem divides above 1.5m. Branches encroaching on footpath. OFFSITE.	Crown lift to 5m. Remove dead wood	20+	B2
T8	Sycamore	LM	22	1300	15	706.95	4E	14-15-12-7	Moderate vitality. Major dead wood. Low bud density. Epicormics on stem. Stem divides above 1.5m. Branches encroaching on footpath. Unbalanced crown shape. OFFSITE.	Crown lift to 5m	10+	C1

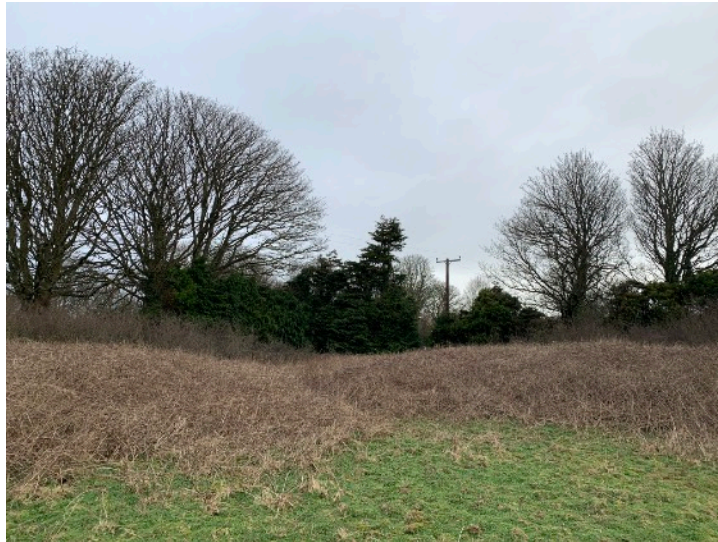
The smaller trees along this site boundary are relatively insignificant and subsumed into large drifts of blackthorn and bramble. The exception to this is a linear feature of three, large sycamore trees towards the site's northern corner. Trees T6, T7 and T8 have stem diameters of 1030, 990 and 1300mm respectively, and the latter two trees exceed 22 metres in height. These trees are all off-site, located as they are on the far side of a little-used public footpath outside the site boundary. Despite being in third-party ownership, these tree contribute to the setting of the proposed development.

Fig 3. Sycamores T7 and T8 to left, T9 and T10 to right.

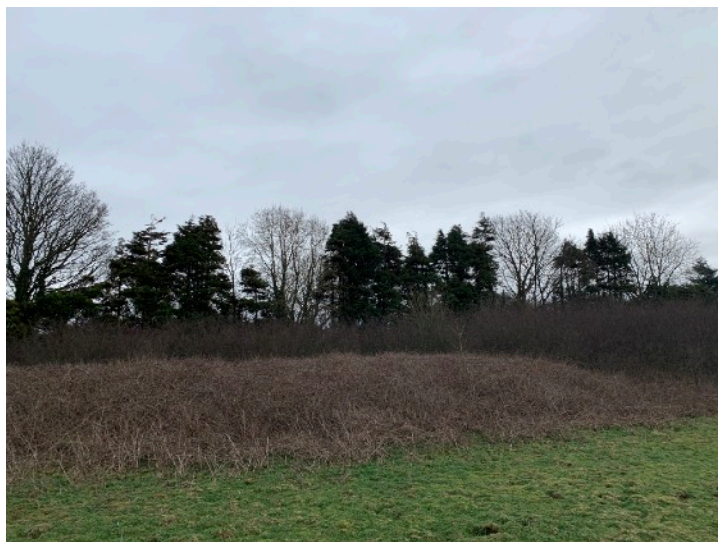
The trees along the northwestern boundary comprise a fairly dense linear feature, comprising two loose parallel rows of trees. The rear row of trees (closest to the boundary fence) comprises intermittent ash and sycamore trees, with fairly spreading crowns. Many of the ash are in fairly poor condition, complying with what has become the local norm for the species. The larger stems in this feature have been picked up individually, but there is a continuous, dense understory of hazel, hawthorn, blackthorn and various deciduous saplings. If thinned and enhanced, these trees could form the basis of a valuable wildlife corridor across the site.

Fig 4. Northeastern boundary- native hardwoods and Leylandii

The inside informal row of trees along the northwestern boundary, comprises an irregular extent of Leyland cypress trees. It may be that this feature was originally planted as a windbreak or screen, but this is no longer effective due to the loss or standing of many of the trees in such exposed conditions. Leyland cypress forms a dense barrier, rather than a permeable layer, and it not ideal for use as a windbreak in any

event. These cypresses offer very little in the way of ornament or biodiversity value, and would be better removed to favour the rear row of native trees and attendant understory.

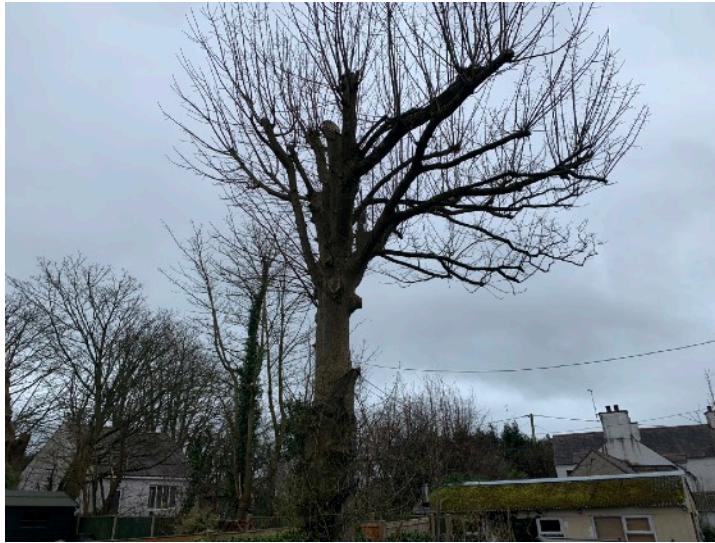
Fig 5. Unappreciated tree on southeastern boundary

The southeastern boundary of the site is staggered and is adjoined by housing. There are two sycamore trees along this boundary (T15 and T16) which are in poor condition, partly due to unsympathetic pruning, and should be removed. The remaining three ash trees here T17, T18 and T19 are in a typically suppressed condition, but which contribute to the vertical structure of this part of the site, and should be retained. All these will require dead-wooding and crown-lifting, as well as needing to be monitored where they overhang roads or buildings.
