Housing Development,
Maes Merddyn,
Brynsiencyn

Trial Pit & Porosity Test
Location Plan & Results

DRAWN	AV	CHECKED	PASSED
DATE	12.04.24	CLIENT'S REF.	
SCALE AT A1	1:250	AUTOCAD REF.	24041/Trial Pits
DRAWING No.			REVISION
24041/001			P04

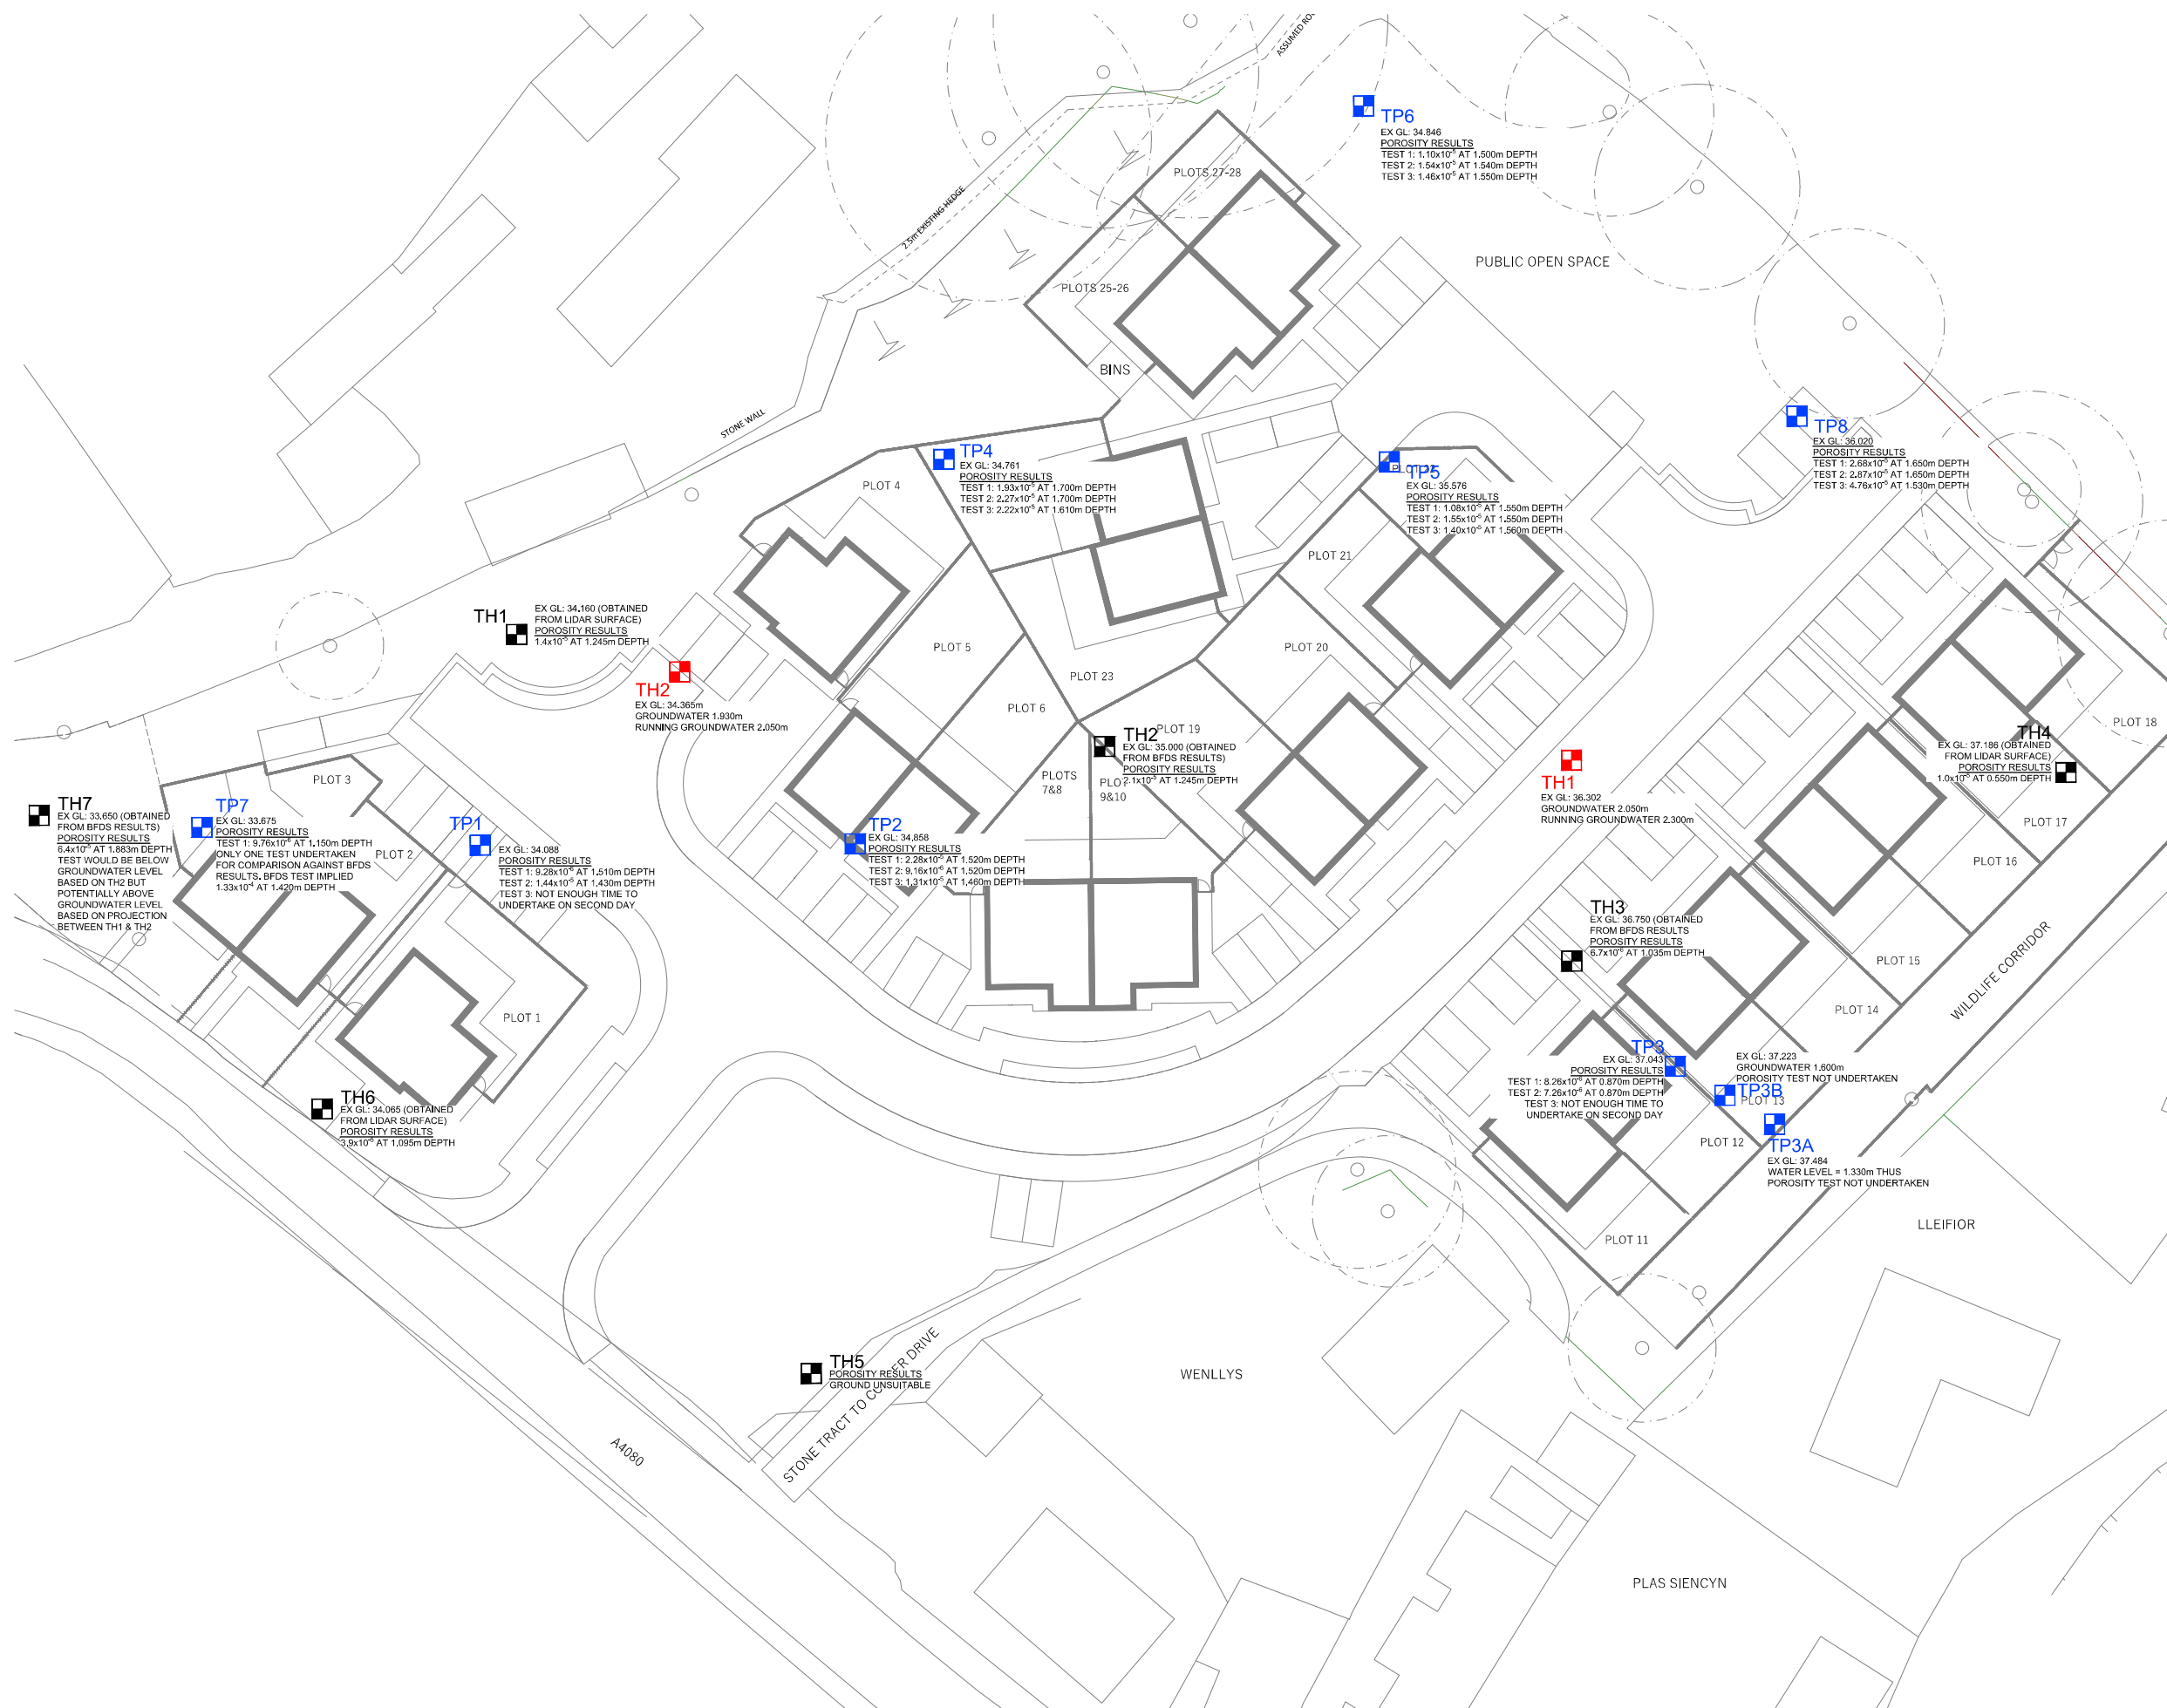
TRIAL HOLE TO DETERMINE UNDERLYING STRATA FOR POROSITY TEST
- TPX

POROSITY TEST
- TPX

POROSITY TEST UNDERTAKEN BY BFDS

Porosity Results Summary Undertaken By Datrys / Williams Homes 09-10/04/24

Porosity Results					
		Depth (m)	Soil Infiltration Rate (m/s)	Vp Rate (m/s)	Comments
TP1	Test 1	1.51	9.28E-06	-	Passed
	Test 2	1.43	1.44E-05	-	Passed
	Test 3	Insufficient time to complete			
TP2	Test 1	1.52	2.28E-05	-	Passed
	Test 2	1.52	9.16E-06	-	Passed
	Test 3	1.46	1.31E-05	-	Passed
TP3	Test 1	0.87	8.26E-06	-	Passed
	Test 2	0.87	7.26E-06	-	Passed
	Test 3	Insufficient time to complete			
TP4	Test 1	1.70	1.93E-05	-	Passed
	Test 2	1.70	2.27E-05	-	Passed
	Test 3	1.61	2.22E-05	-	Passed
TP5	Test 1	1.55	1.08E-05	-	Passed
	Test 2	1.55	1.55E-05	-	Passed
	Test 3	1.56	1.40E-05	-	Passed
TP6	Test 1	1.50	1.10E-05	-	Passed
	Test 2	1.54	1.54E-05	-	Passed
	Test 3	1.55	1.46E-05	-	Passed
TP7	Test 1	1.15	9.76E-06	-	Passed
TP8	Test 1	1.65	2.68E-05	-	Passed
	Test 2	1.65	2.87E-05	-	Passed
	Test 3	1.53	4.76E-05	-	Passed

Porosity Results Summary Undertaken By BFDS 11/01/2016

Porosity Results					
		Depth (m)	Soil Infiltration Rate (m/s)	Vp Rate (m/s)	Comments
TH1	Test 1	1.245	1.40E-05	-	Passed
TH2	Test 1	1.245	2.10E-05	-	Passed
TH3	Test 1	1.035	6.70E-06	-	Passed
TH4	Test 1	0.55	1.00E-05	-	Passed
TH5	Test 1	Ground unsuitable			
TP6	Test 1	1.10	3.90E-05	-	Passed
TP7	Test 1	1.15	6.40E-05	-	Passed
