## MARCHOGION INCLINED PLANE, BANGOR

Landscape Condition Assessment and Restoration Strategy

April 2025

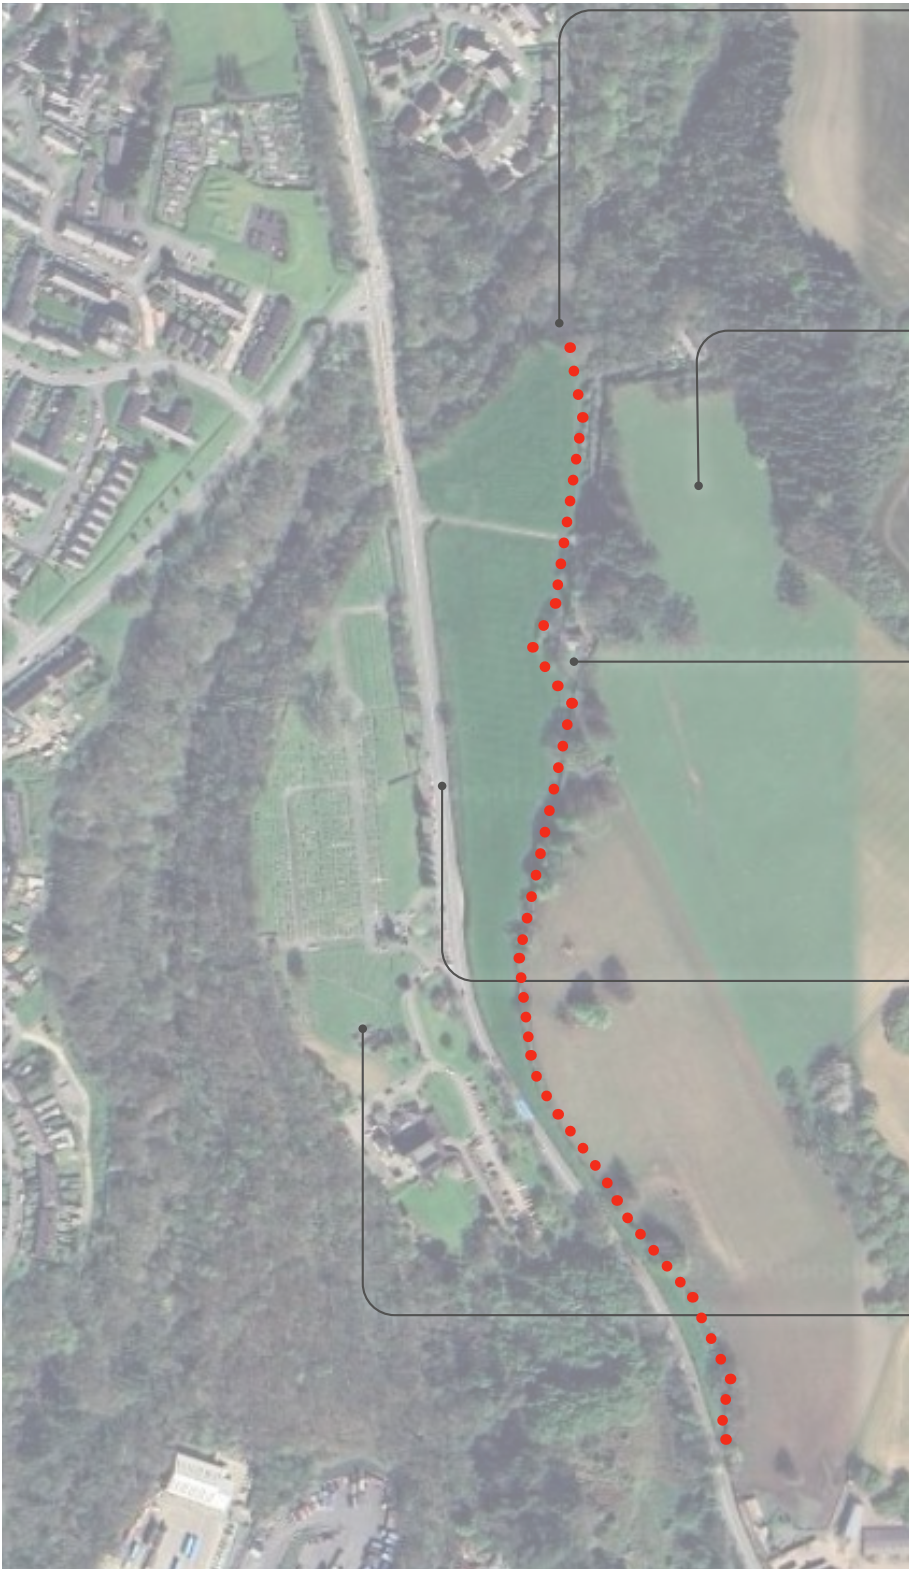
Coed Cegin Ancient Woodlands

Grounds of Penrhyn Castle

Grade II Listed Incline Cottage

A5 / Llandegai Road

Bangor Crematorium and  
Mynwent Newydd Cemetery

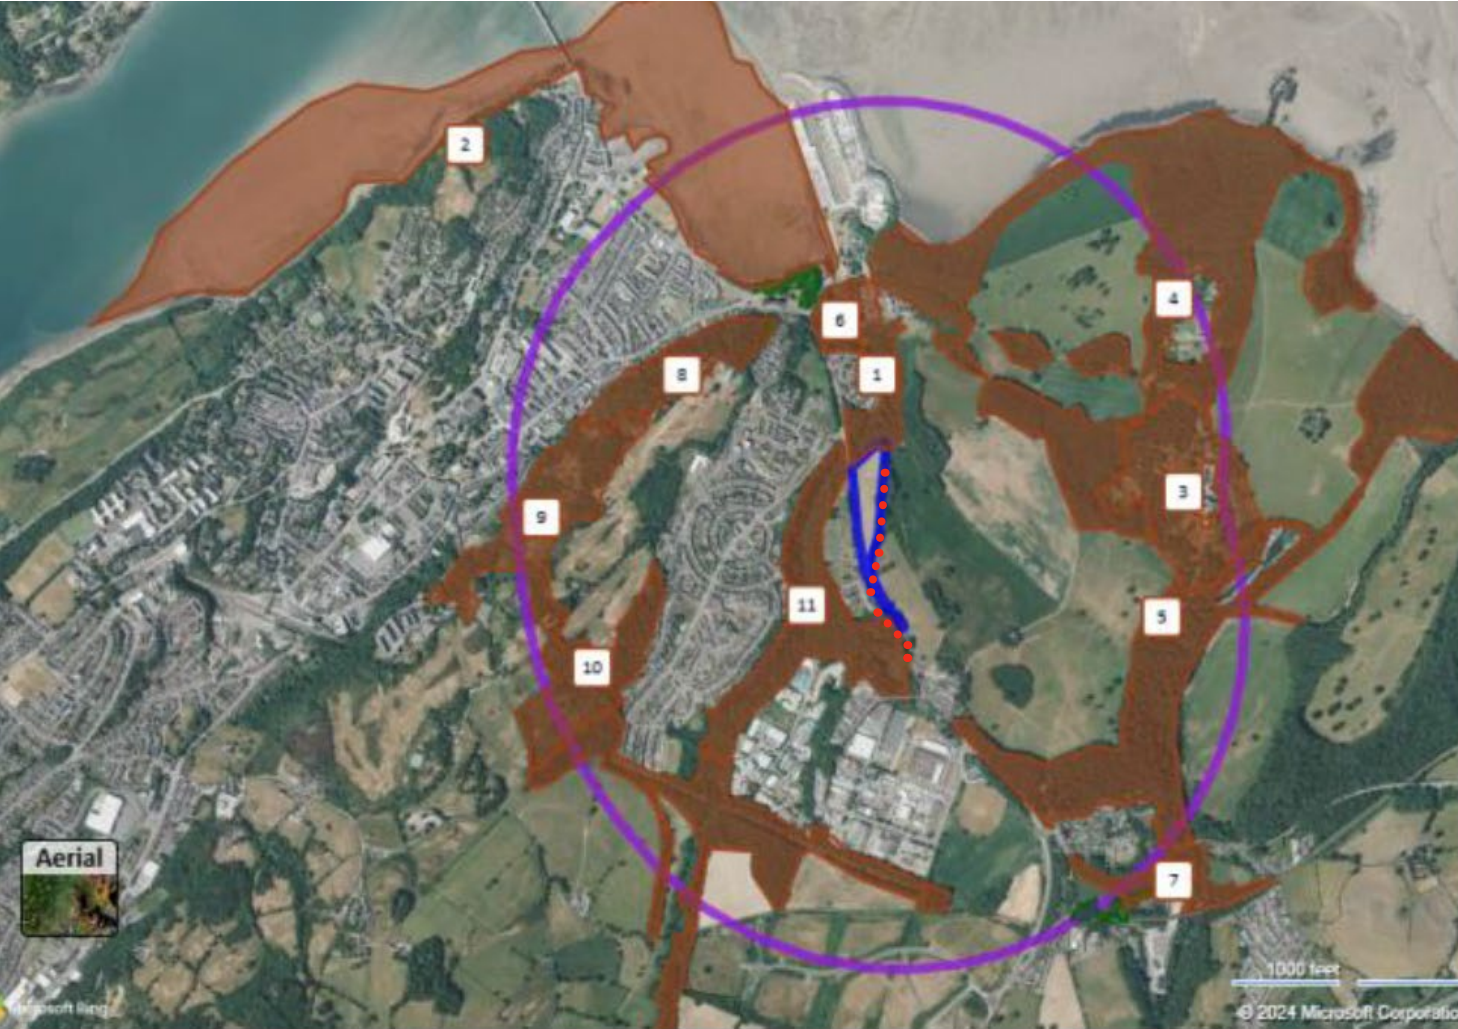
Figure 4.2 Wildlife sites within 1km of the survey area  
(Image from Cofnod, Base image © Microsoft Corporation 2024)

“4.1.2 There were 12 non-statutory designated wildlife sites within 1km of the survey area, as shown in Figure 4.2 below. All of the sites within 300m of the survey area (site 1, 5, 6, 11) are special for their woodland, amongst other features. Of the sites adjacent to the survey area, salmon, otter, red

4.1.3 The site labelled as Site 1 in Figure 4.2, Coed Cegin Candidate Wildlife Site, includes the broadleaved woodland in the north-eastern corner of the survey area. Site 11 (Llandegai Wildlife Site), designated for its broadleaved woodland amongst other features, in places forms a continuous canopy with hedge and trees on the survey area despite the intervening road.

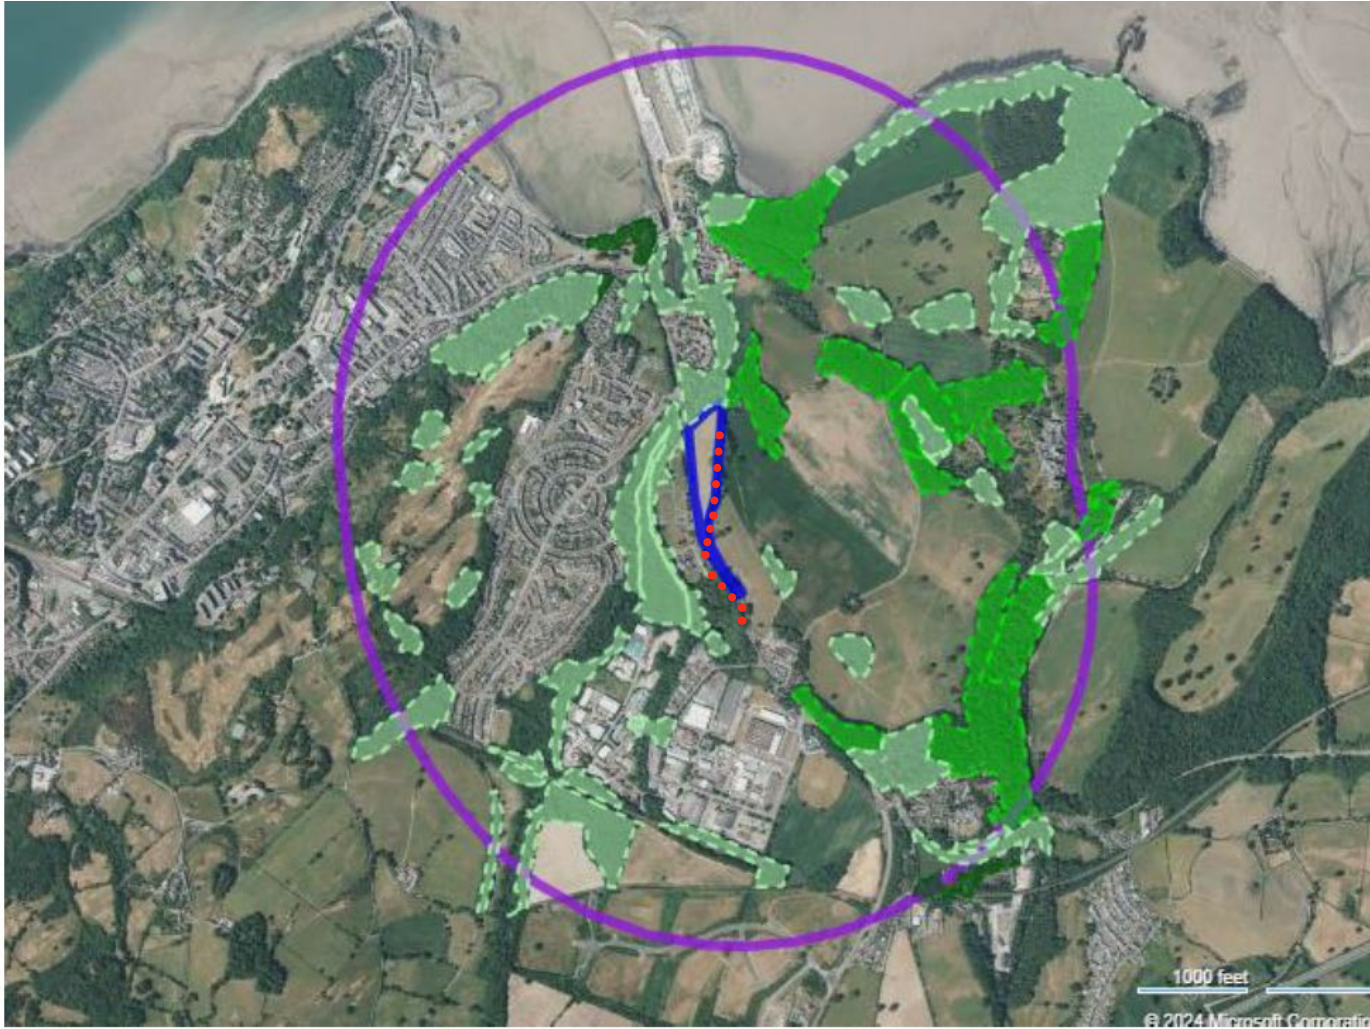
Figure 4.3 Areas of ancient woodland within 1km of the survey area.  
(Image from Cofnod, Base image © Microsoft Corporation 2024)

4.1.4 There were many areas of ancient woodland within 1km of the survey area, as can be seen in figure 4.3, below. The pale green areas indicate restored ancient woodland and the lime green indicates plantations on

ancient woodland sites. The mid green areas on the northern coastal edge and south-eastern edge of the 1km search area are ancient semi-natural woodland. One area of restored ancient woodland is close to the northern border of the survey area, and includes the small areas of broadleaved woodland inside the survey area. An area of plantation on ancient woodland site is close to the northern tip of the site.

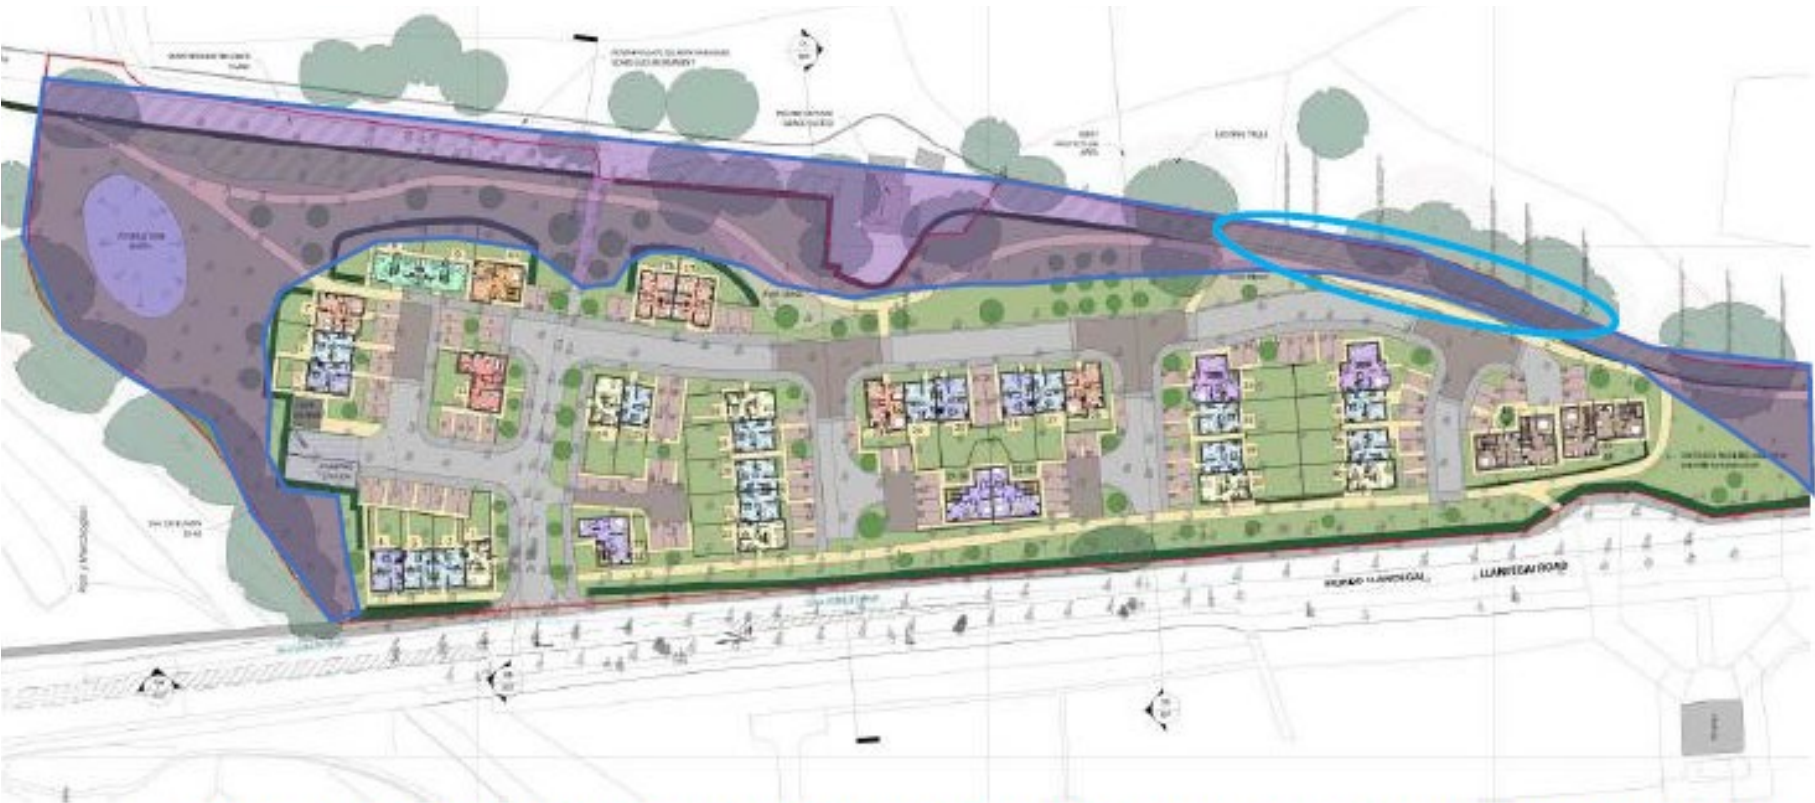
FIGURE 4.2: PROPOSED DARK ZONES (BELOW 1 LUX AT GROUND LEVEL) IN PURPLE.  
TAKEN FROM SITE PLAN © AINSLEY GOMMON ARCHITECTS.

The dark corridors for bats will be maintained through control of lighting including the use of baffles on the rear of the street lights, particularly where these are close to the boundaries in the southeast of the site. Refer to the lighting plan for further details (however it should be noted that the software used to plot isolines cannot model these baffles at present, so some lighting spillage shown on the boundary here will not in fact be present on site (area circled in blue on Figure 4.2 below). **A corridor including all of the trees on the northern and eastern boundaries, plus as much as possible of the grassland in front of them has been kept dark in order to avoid disturbing the established bat flight lines. In the north of the site this dark area comprises the entire area north of the buildings, 20-40m in depth, while it will be a minimum of 2-3 metres in the east, and generally much wider.** Modelling was available to 1 lux, but areas beyond this point are entirely unlit and are anticipated to drop to natural night-time light levels of 0.2 lux or less (see Figure 4.2).

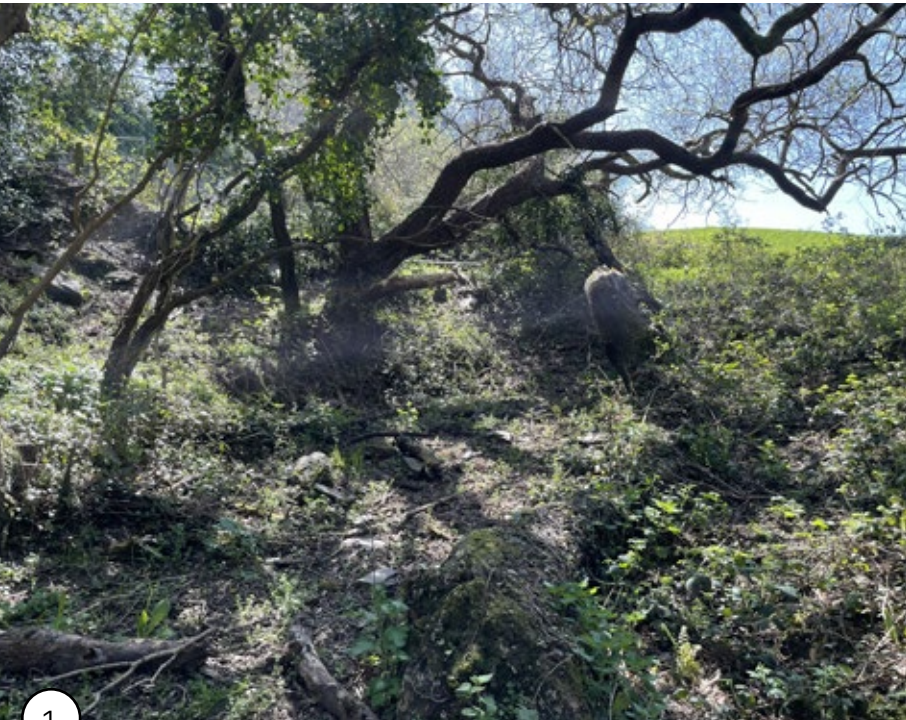
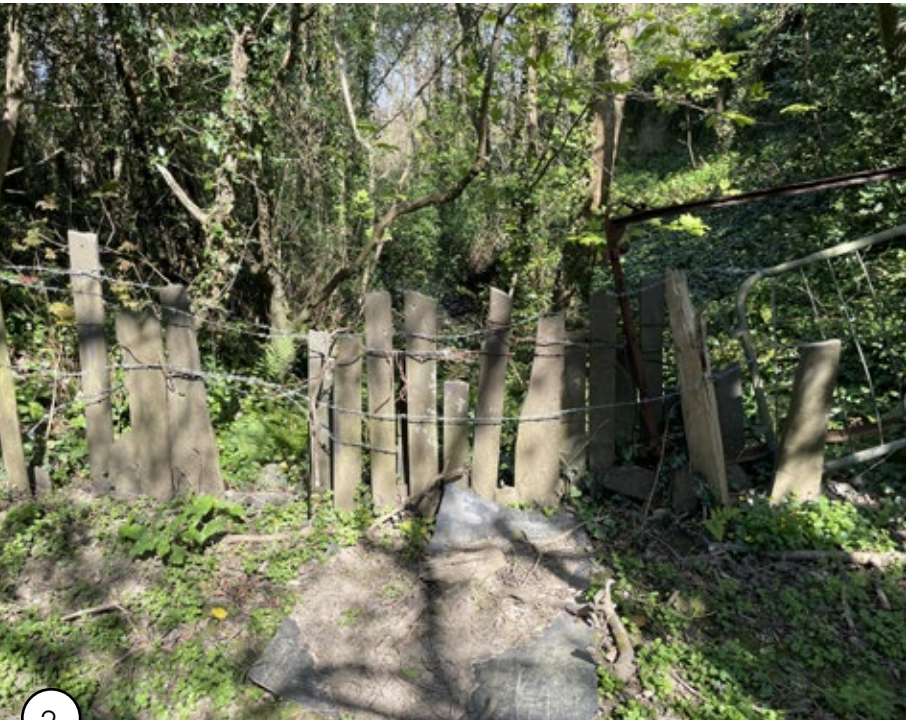
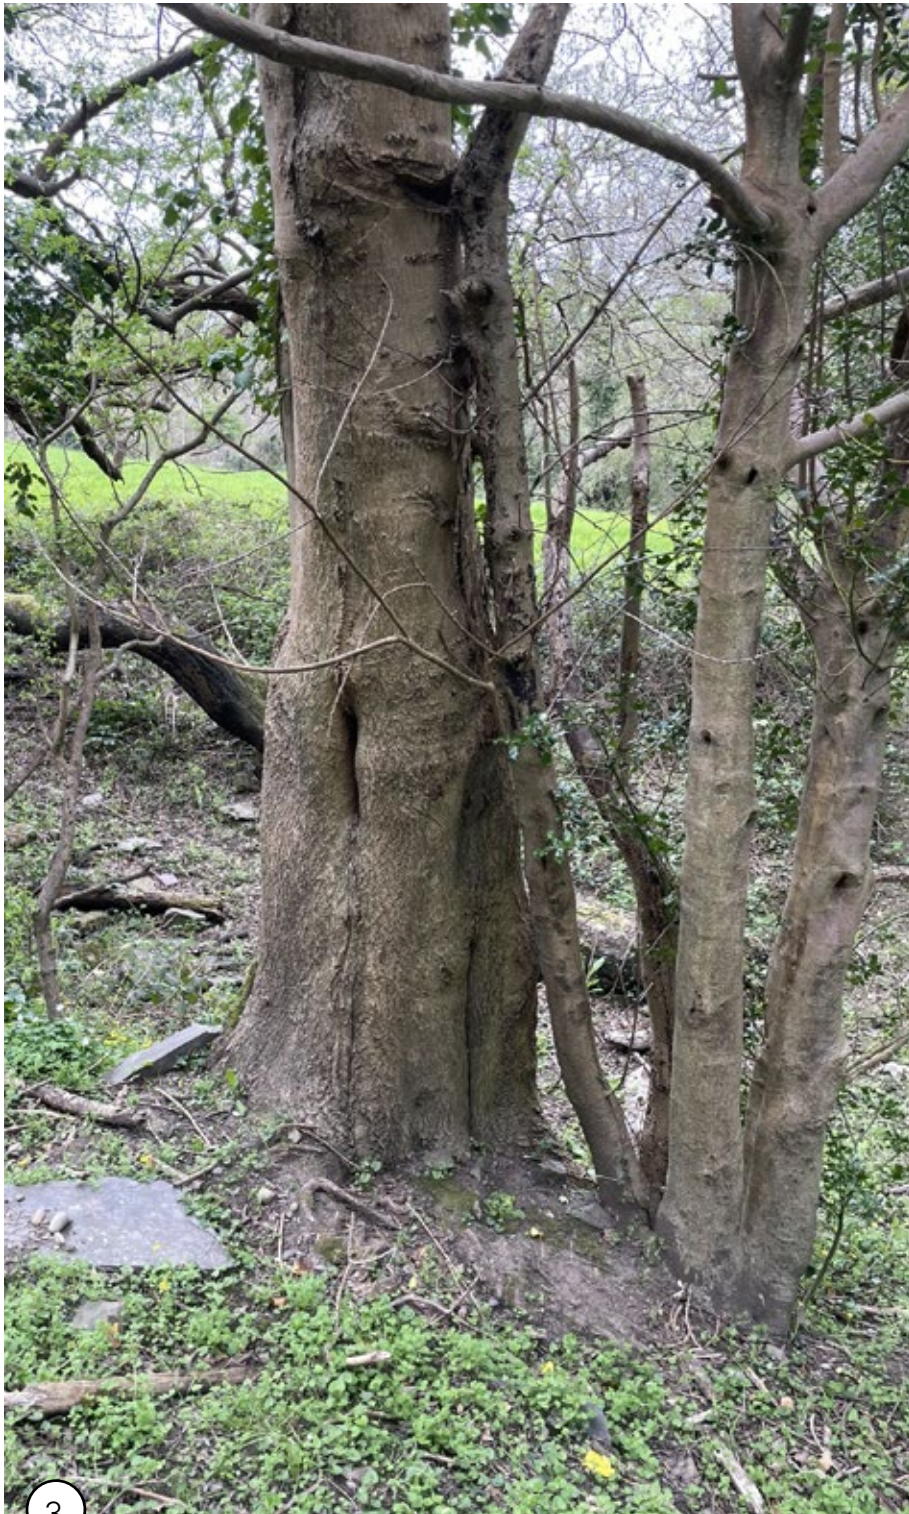
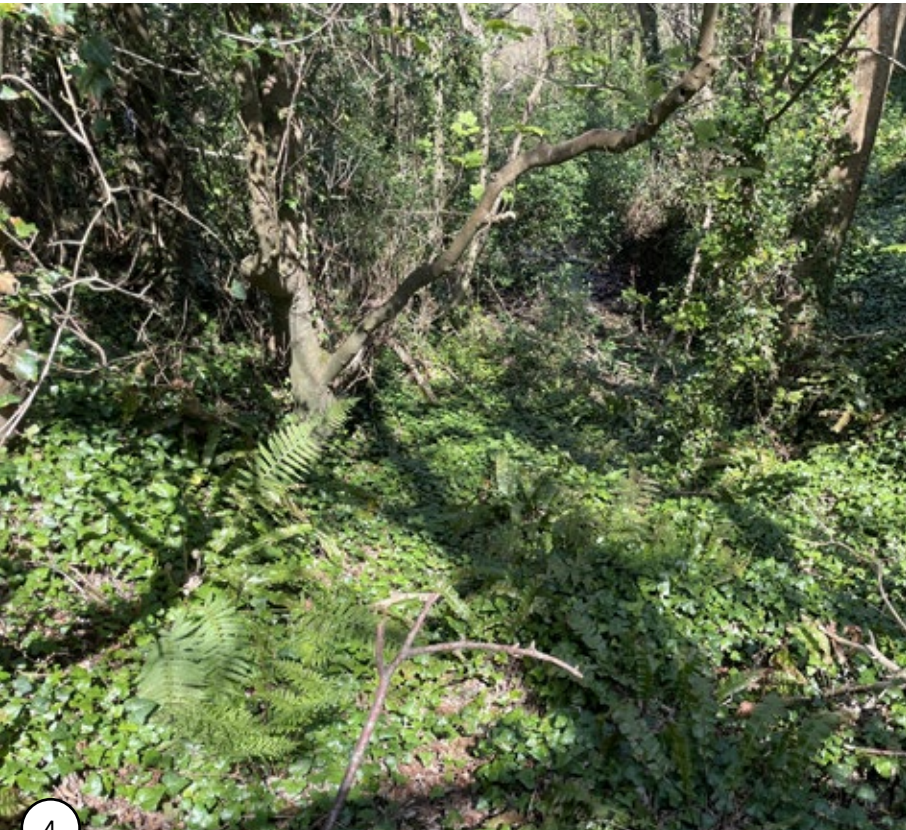
- 1. View from within the woodland, looking uphill towards the open field
- 2. Remnants of distinctive slate fencing separating the upper level of the site with the area of ancient woodland to the north
- 3. Existing stand of mature trees, the area has several species including Ash, Hawthorn, Holly and Goat Willow
- 4. Below the slate fence adjacent to the site is a glade carpeted with Harts Tongue Ferns and other Ancient Woodland species. This area is presumed to be part of the former marshalling yard for the railway line

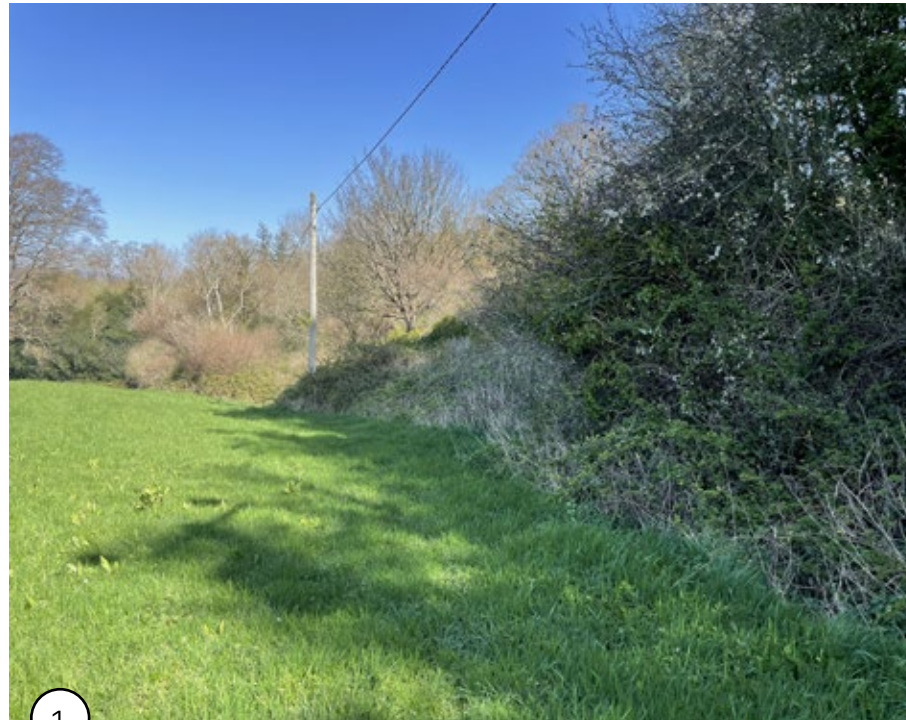
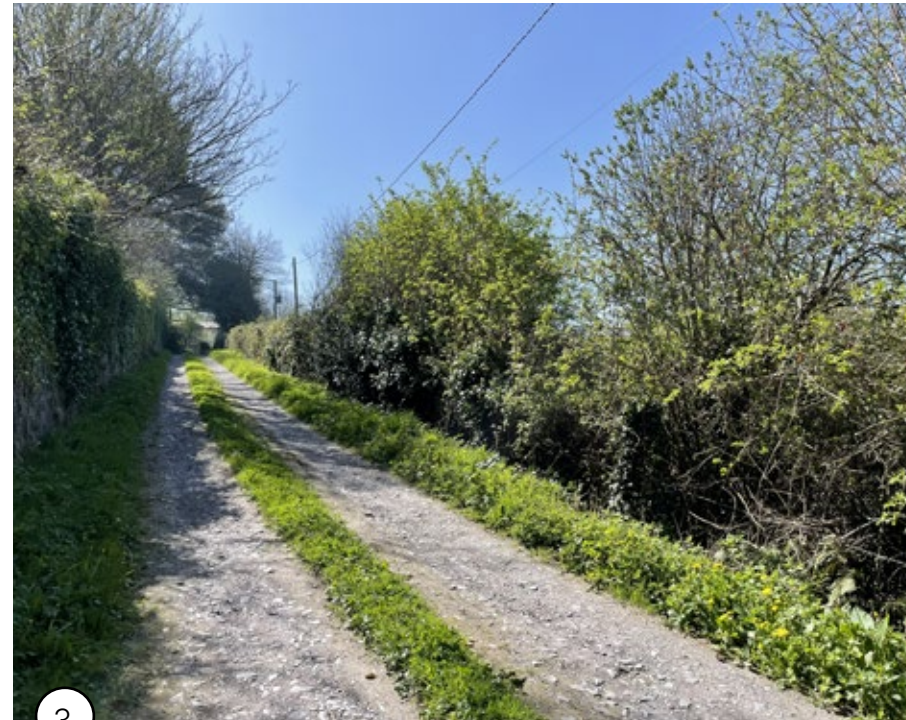
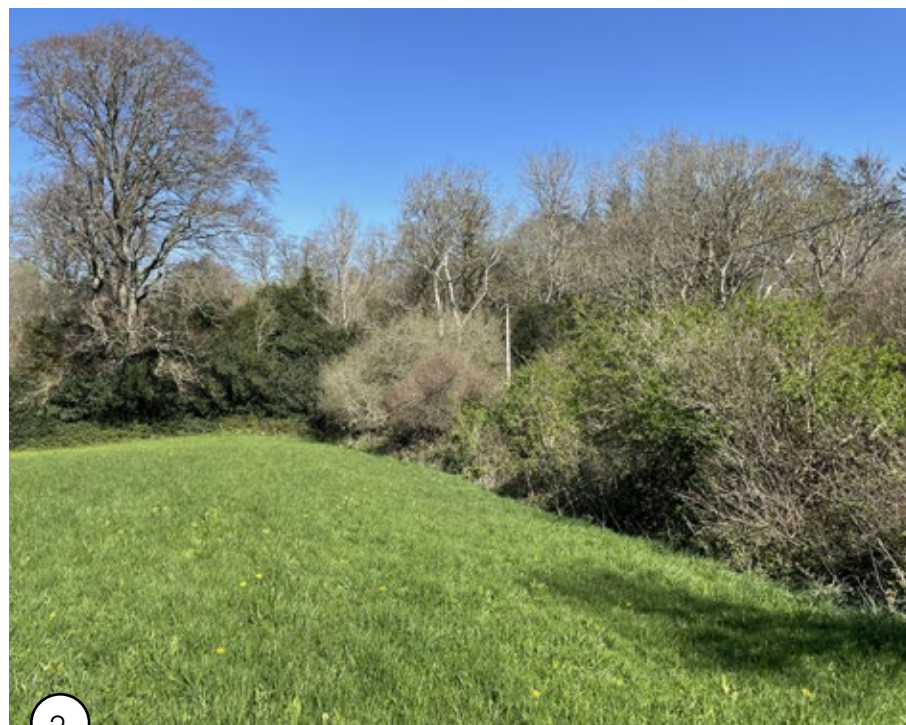
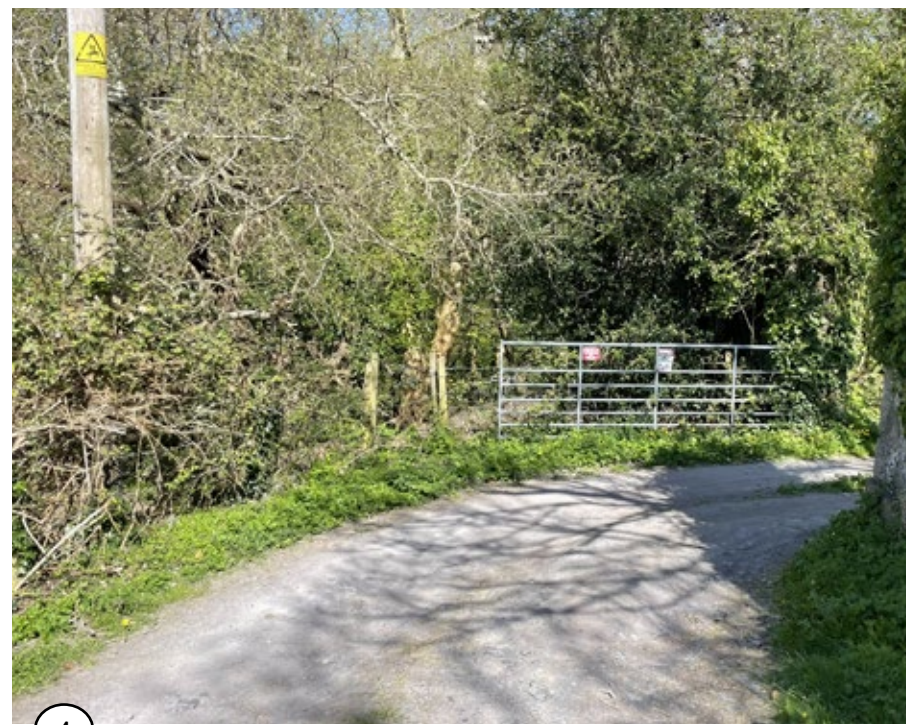
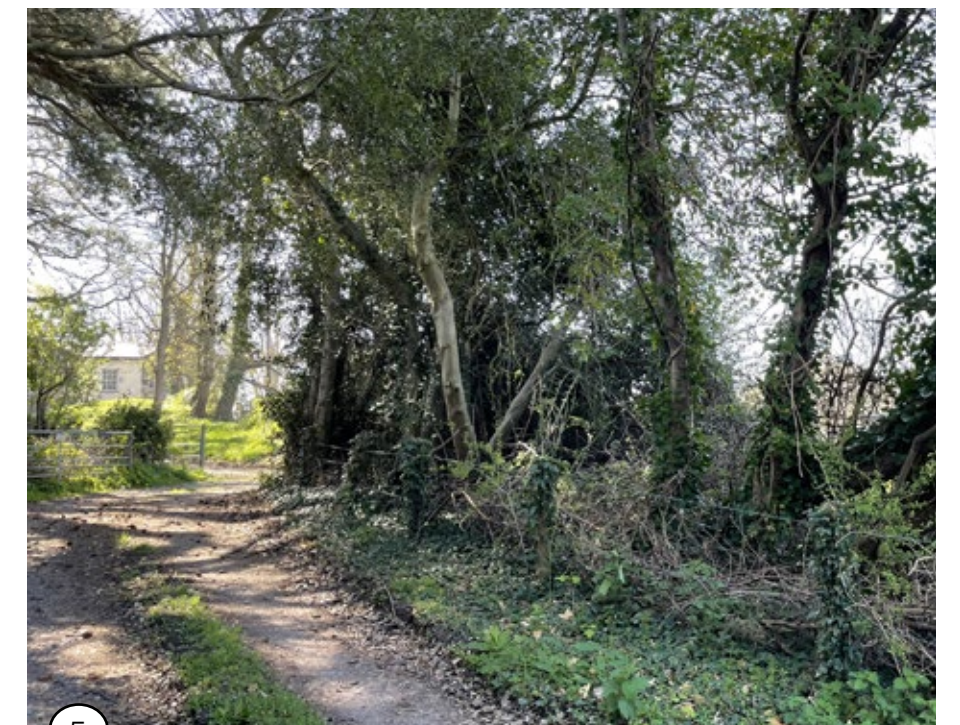
1. View from open field towards north portion of Inclined Plane and scrub / hedgerow. Note that several utility poles currently site within the monument
2. View of Inclined Plane where angle of earthworks is clearly visible
3. View from access drive to private residence that runs parallel to Inclined Plane along eastern boundary (looking south)
4. View from access drive to private residence that runs parallel to Inclined Plane along eastern boundary (looking north)
5. Stand of mature Holly trees adjacent to entrance drive that accesses both Incline Cottage and other private residence

Species found in this area include Bramble, Blackthorn, Ivy, Sycamore, Elder, Holly and some non native species such as Vinca

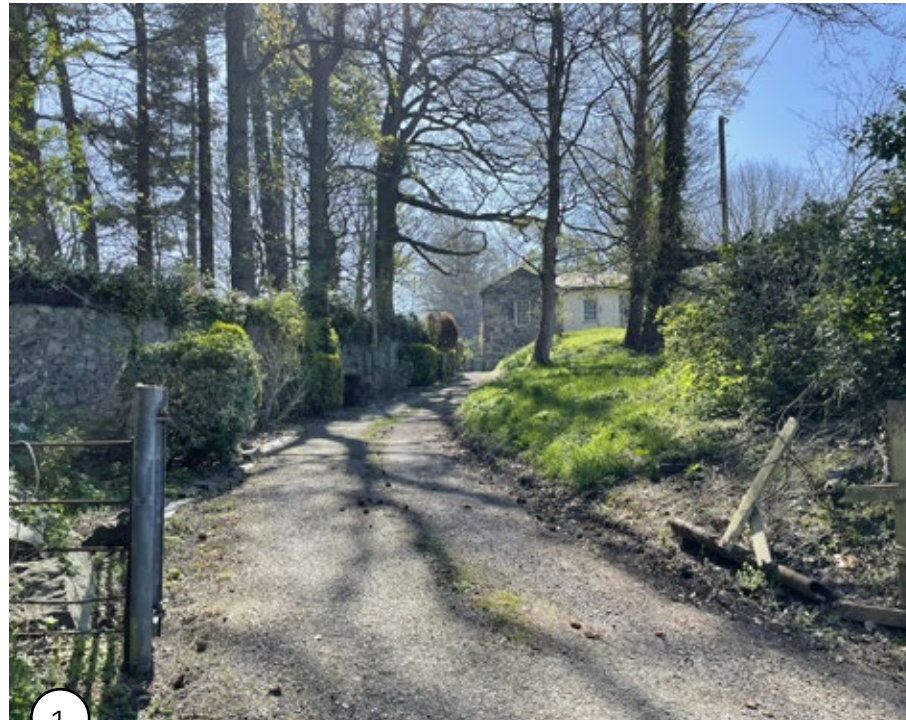
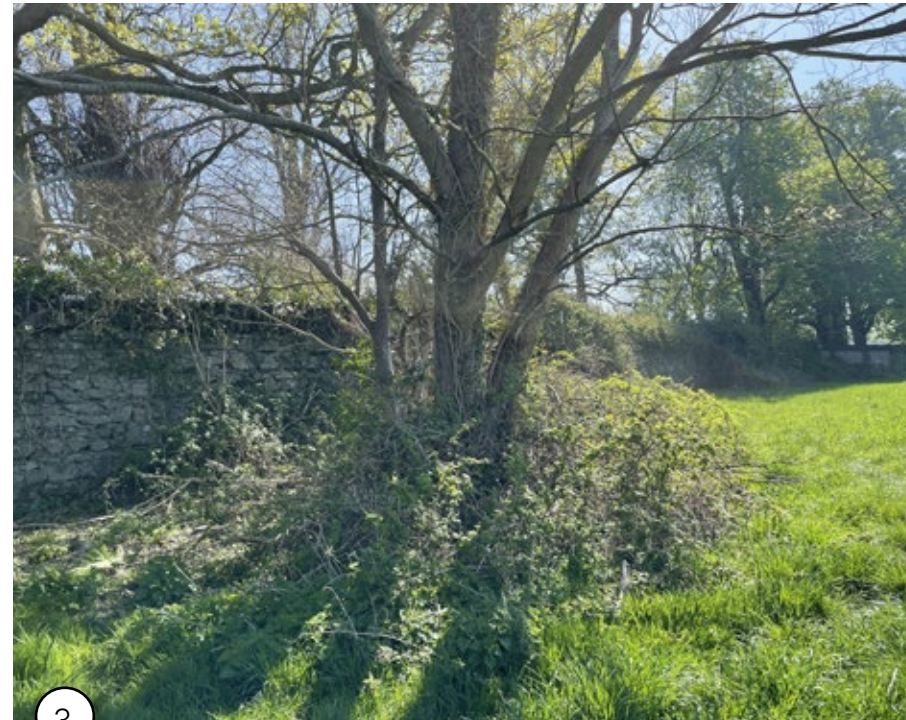
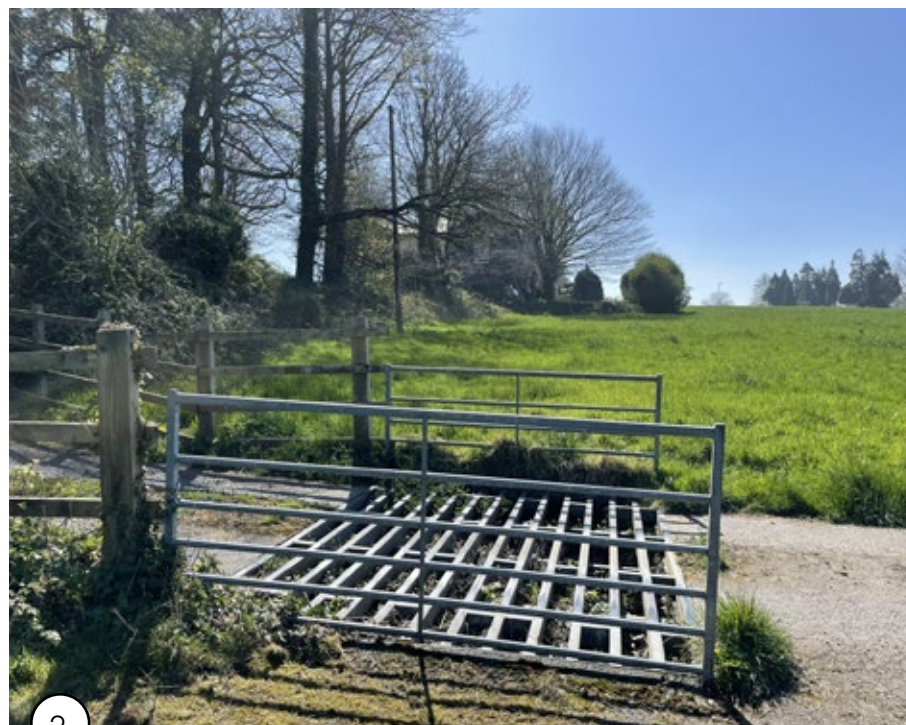
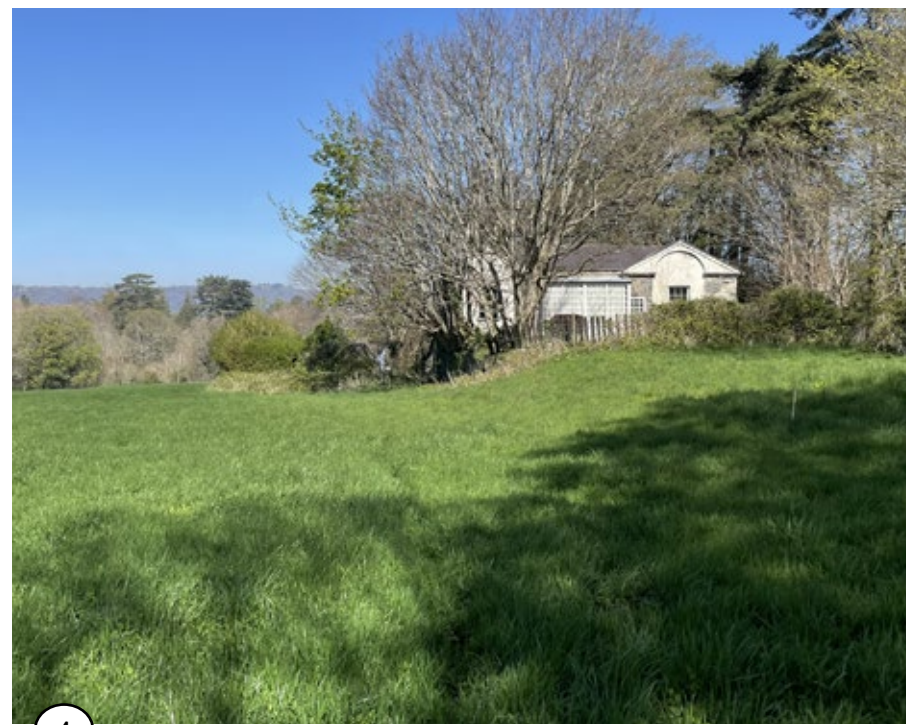
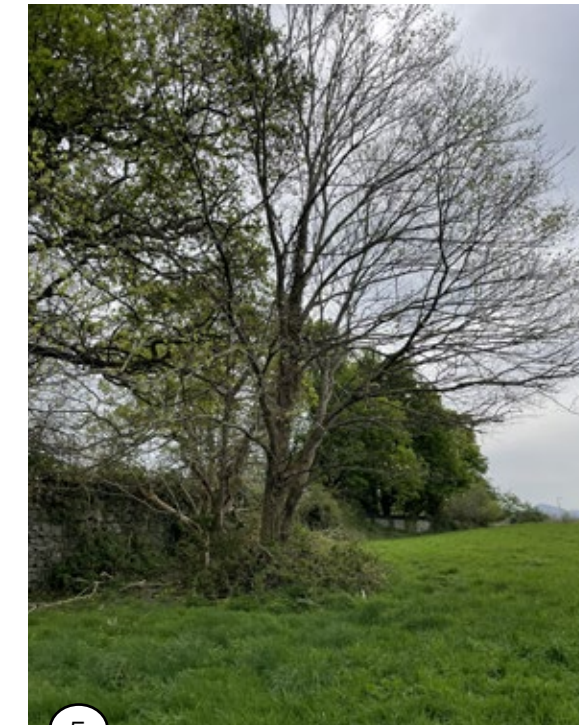
1. View from entrance drive looking south towards cottage
2. Entrance drive with cattle grate
3. Existing stand of mature trees including Elm, to south of cottage
4. View of cottage with existing vegetation and trees surrounding house and garden
5. Existing mature Willow tree near cottage along wall

Species found in this area include Elm, Ash, Bramble and some scrub as well as a Privet hedge and other ornamental plantings within the private garden.

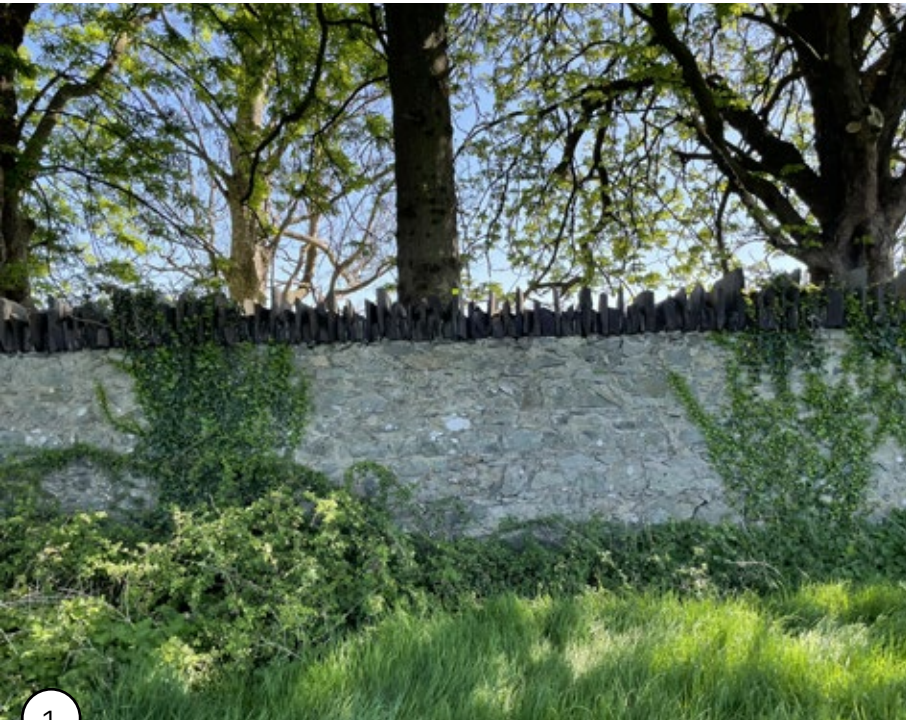
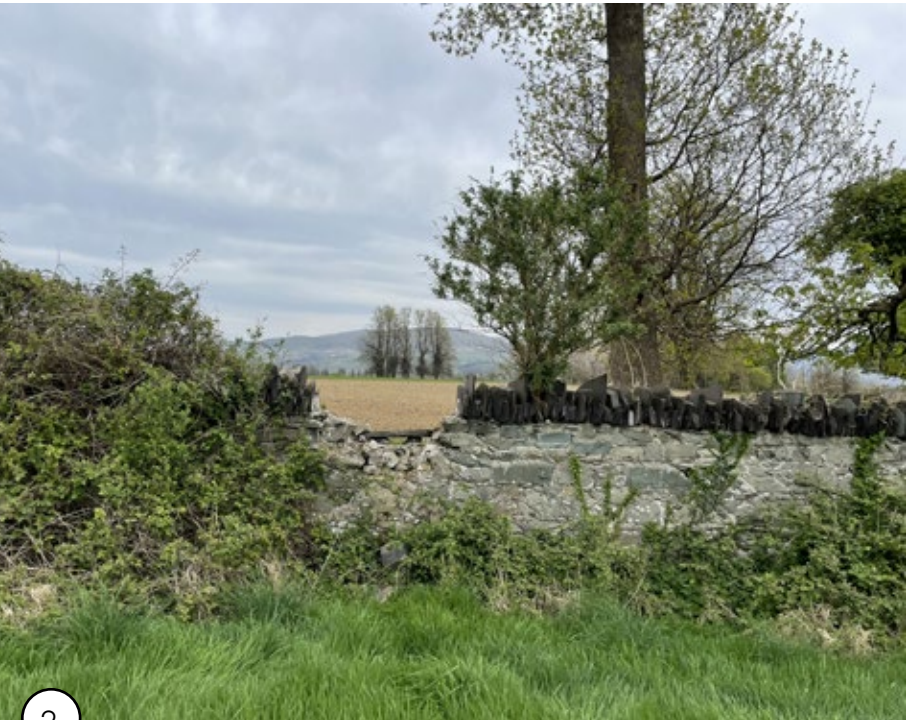
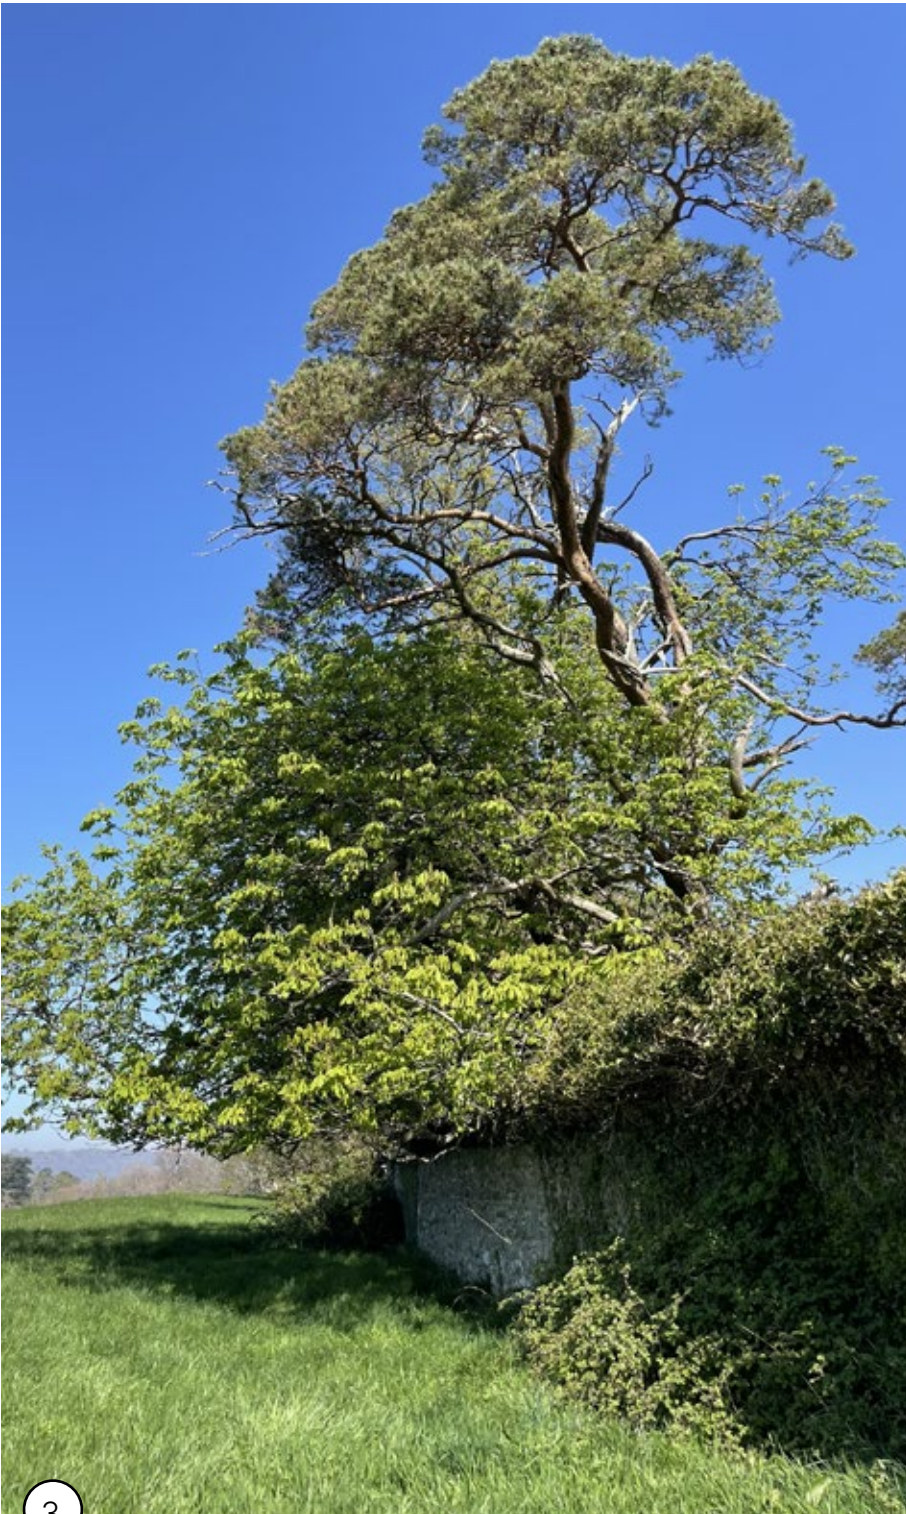
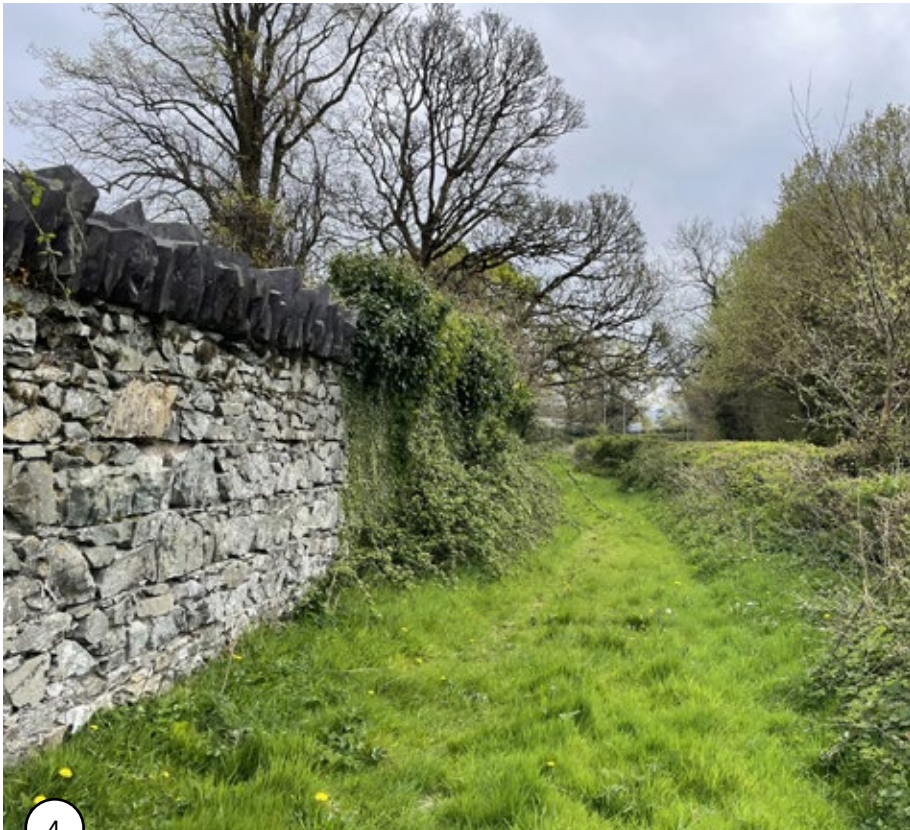
The southern portion of the Inclined Plane follows the boundary of the adjacent Penrhyn Castle Registered Historic Park & Garden, with distinctive stone walls topped with slate uprights. Some vegetation, primarily bramble, dog roses and scrub, is growing intermittently along the wall and there are climbing plants such as ivy on the wall itself.

- 1. Typical section of wall with ivy and low scrub in front
- 2. Damaged portion of wall with scrub in front and estate gardens in distance
- 3. Several mature trees, such as this Horse Chestnut, overhang the wall from the estate side
- 4. The very southern tip of the Inclined Plane brings the western hedgerow of the site close to the wall and scrub, allowing only a narrow pathway through. The Llandegai Road/A5 is immediately adjacent to the hedgerow on the right in this image
