## MARCHOGION INCLINED PLANE, BANGOR

Landscape Condition Assessment and Restoration Strategy

April 2025

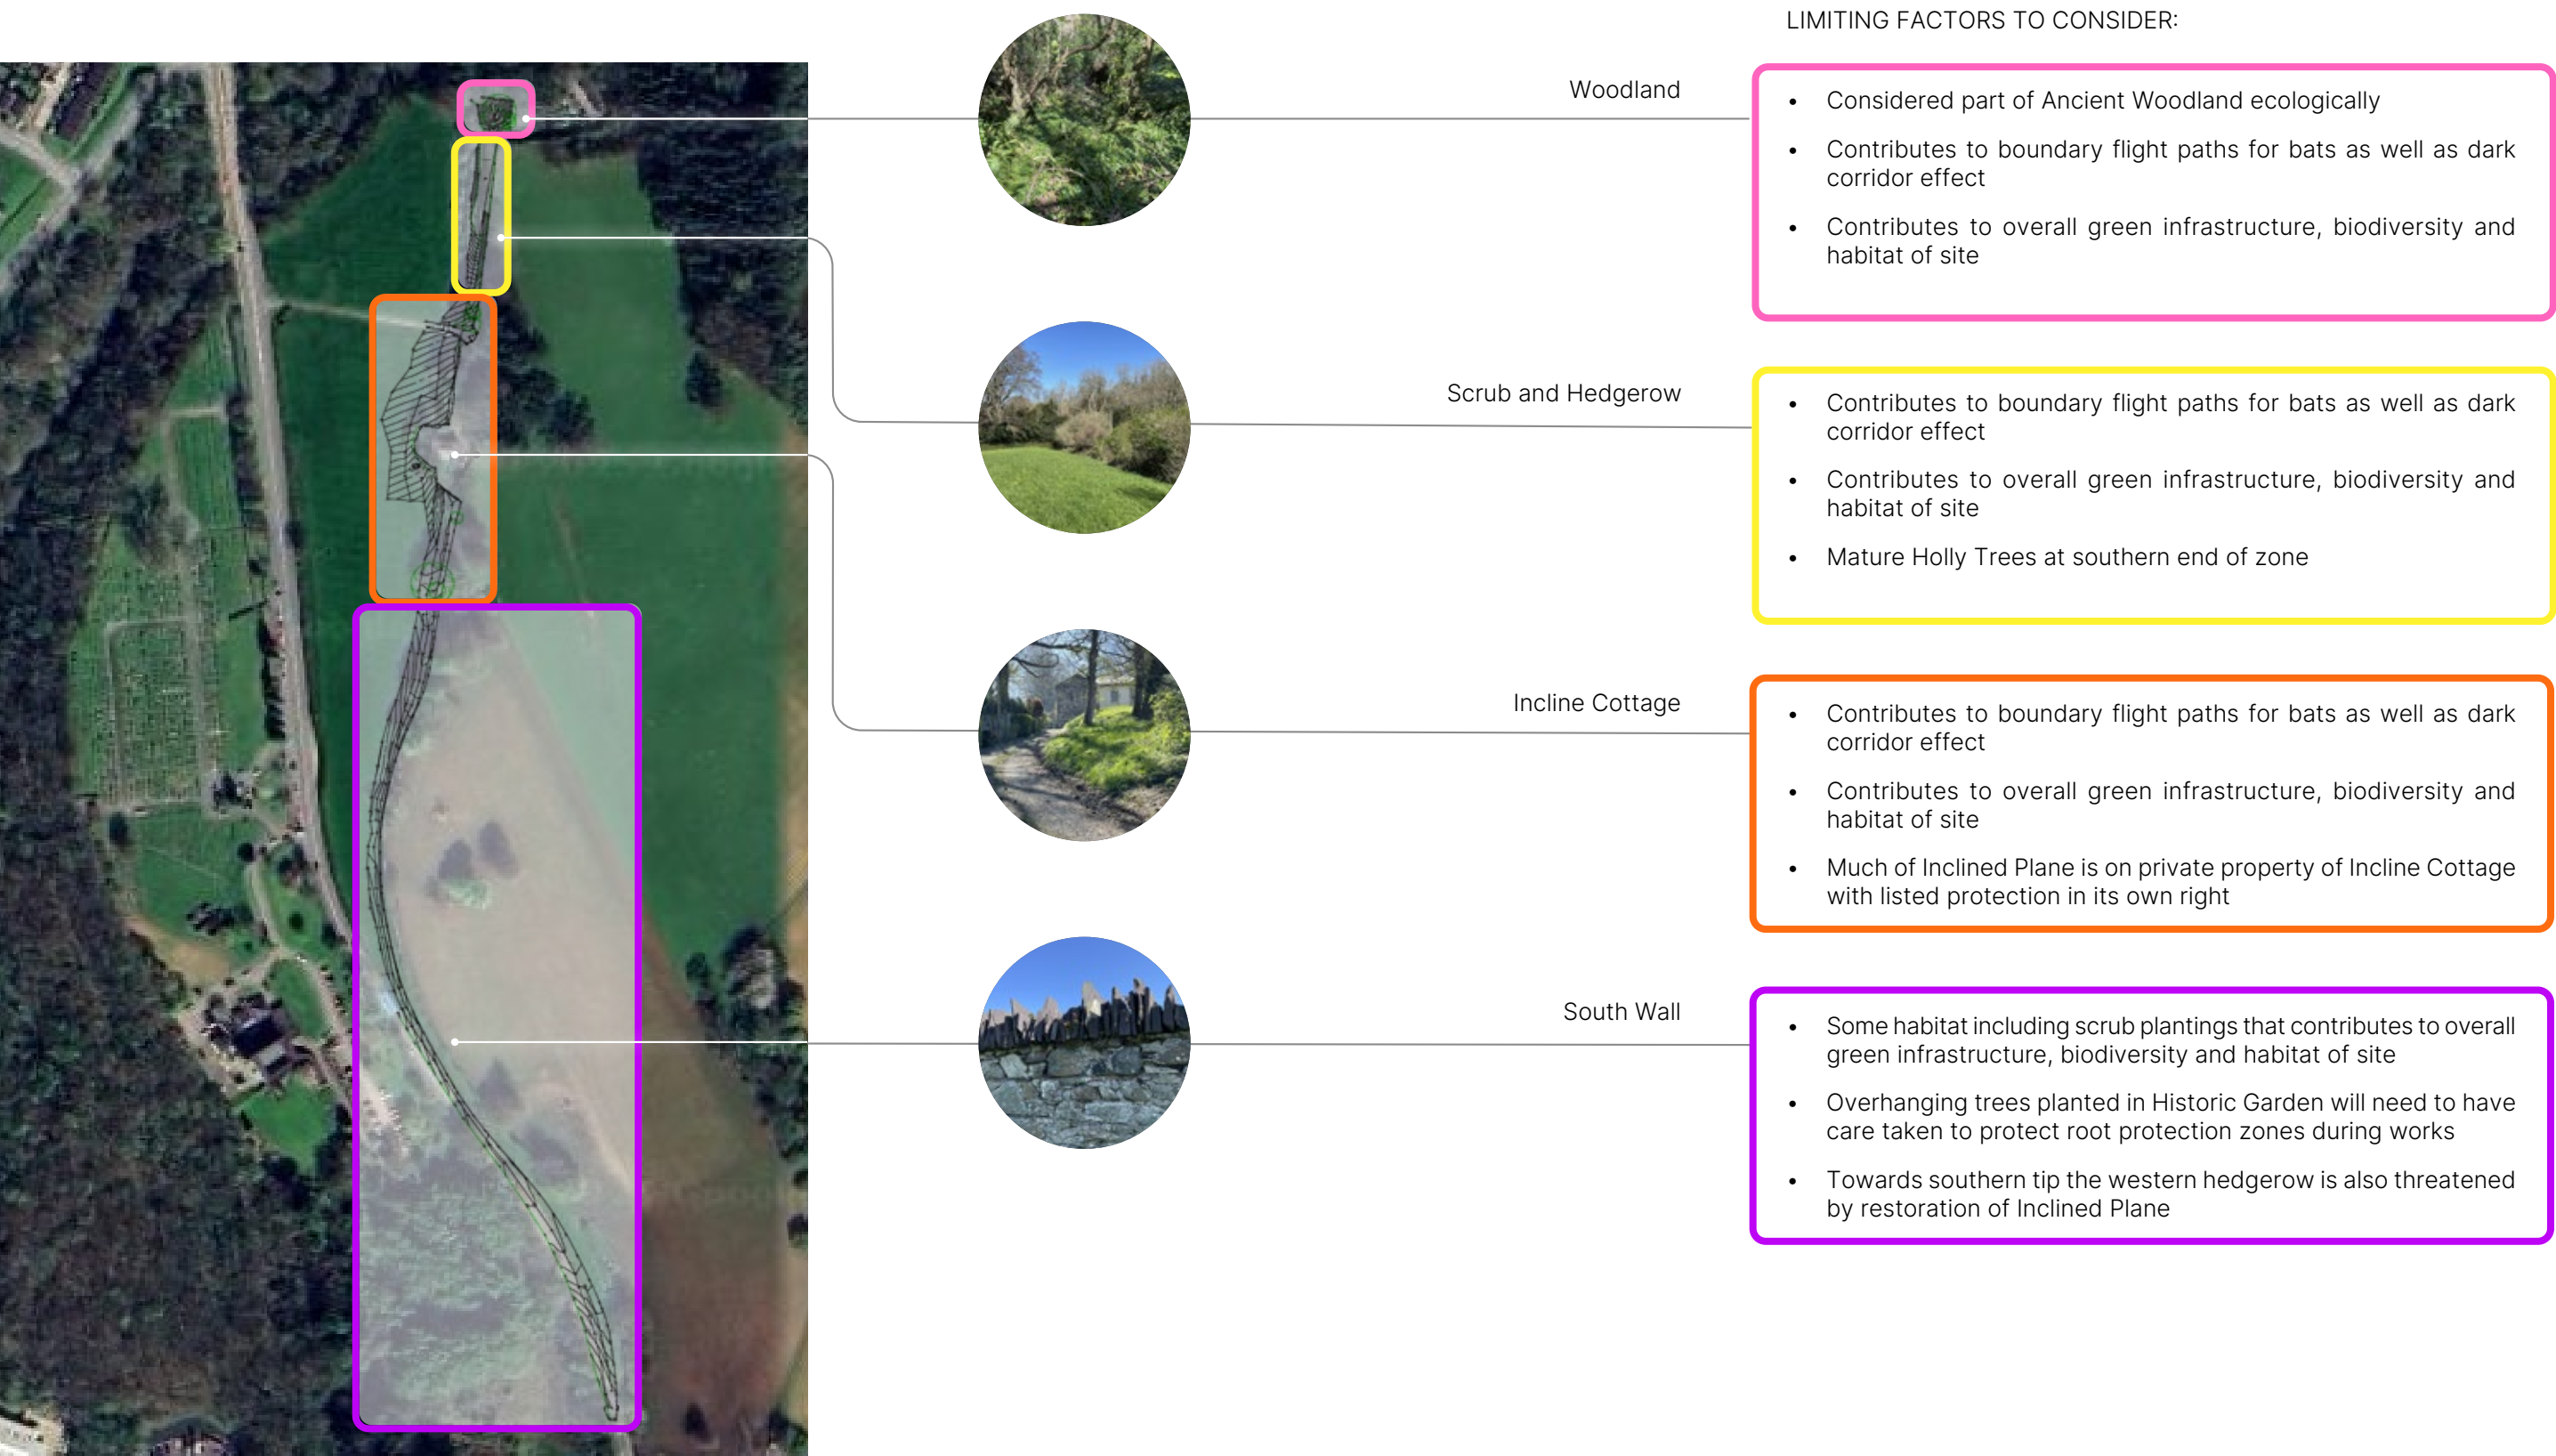
Each of the site zones has different factors that influence the restoration and management of the Inclined Plane. Six species of bats have been recorded in flight along the eastern boundary, so ecological considerations are a major influence.

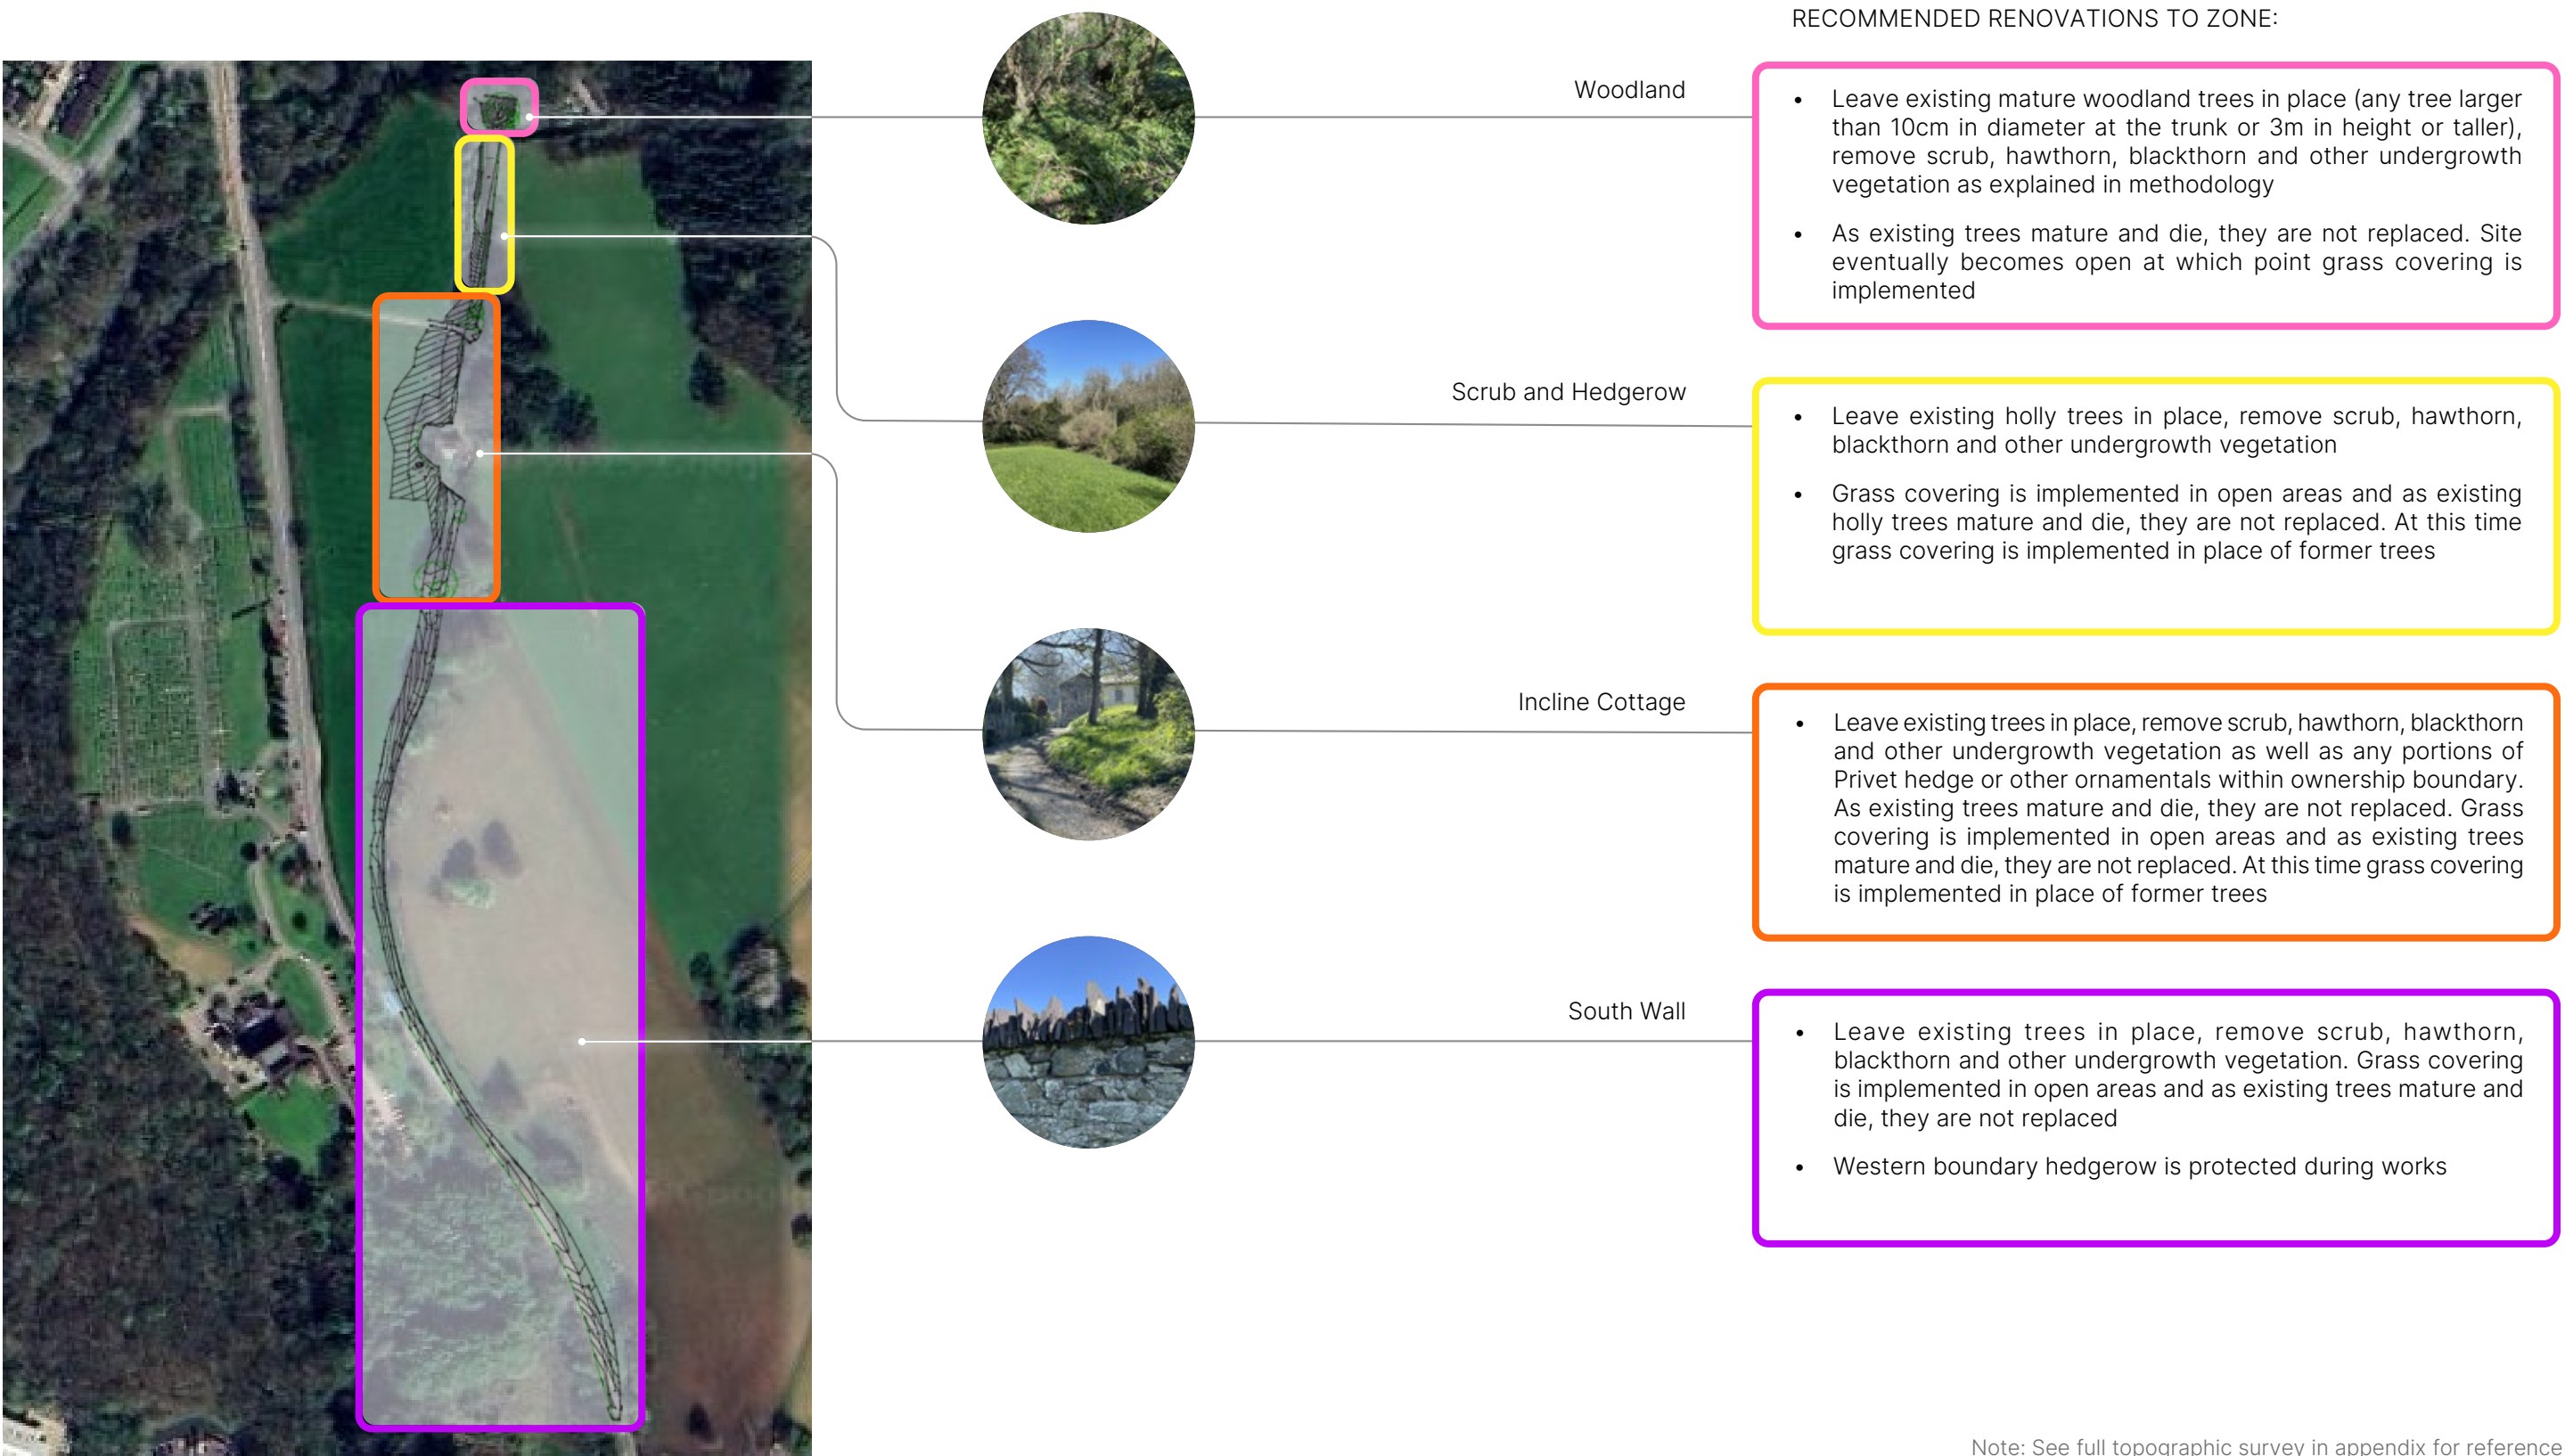
For restoration of the Inclined Plane, the strategy is to carefully remove the smaller vegetation, with the established mature trees retained until such time as they naturally die, at which point the stumps are cut to the ground and they are not replaced. A grass covering is planted on the open portions of the Inclined Plane. Mitigating tree plantings are specified further to the west within the site, for both bat flightways and maintenance of dark corridors on the eastern boundary.

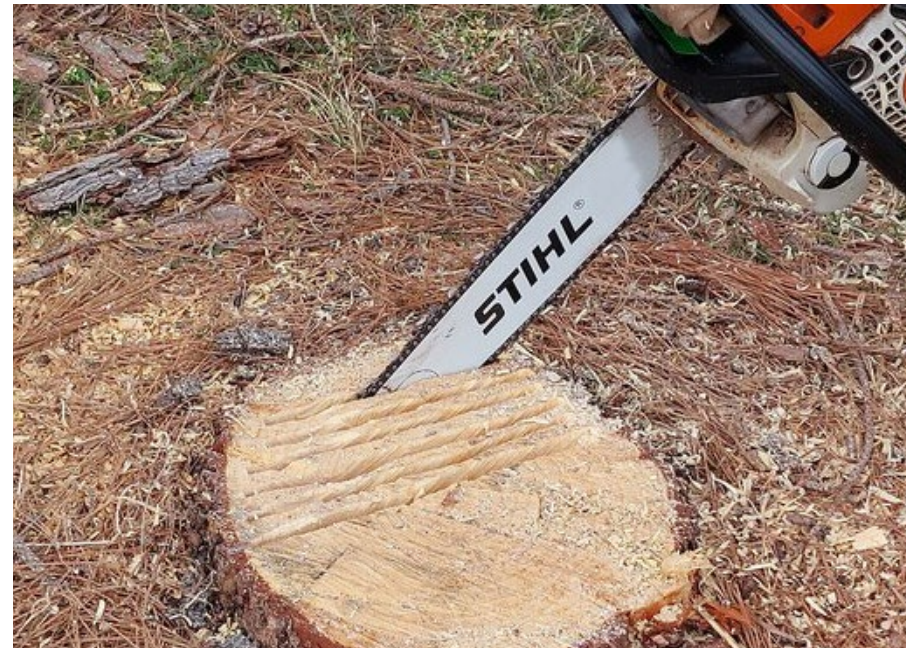
Stump removal should be done carefully to avoid damaging the earthworks of the ancient monument. Once cut to ground level, regular mowing will prevent regrowth of tree sprouts

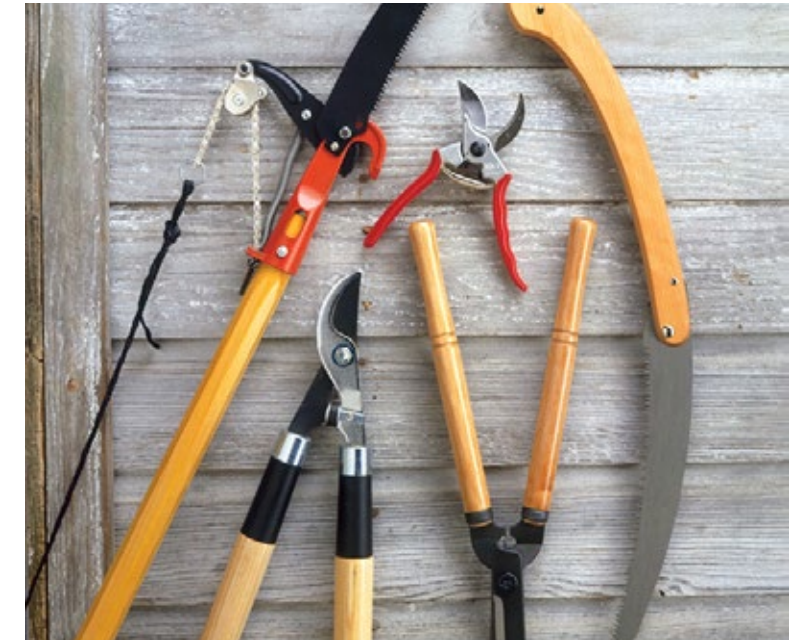
Acceptable hand tools for removal of existing vegetation

- Use hand tools for smaller vegetation such as shrubs and small trees, i.e. secateurs, pruning saw, etc. Powered machinery such as chainsaws should be used sparingly and only on tree trunks themselves, great care should be taken to not damage the ground surface during works.
- All vegetation to be removed should be cut back to the ground.

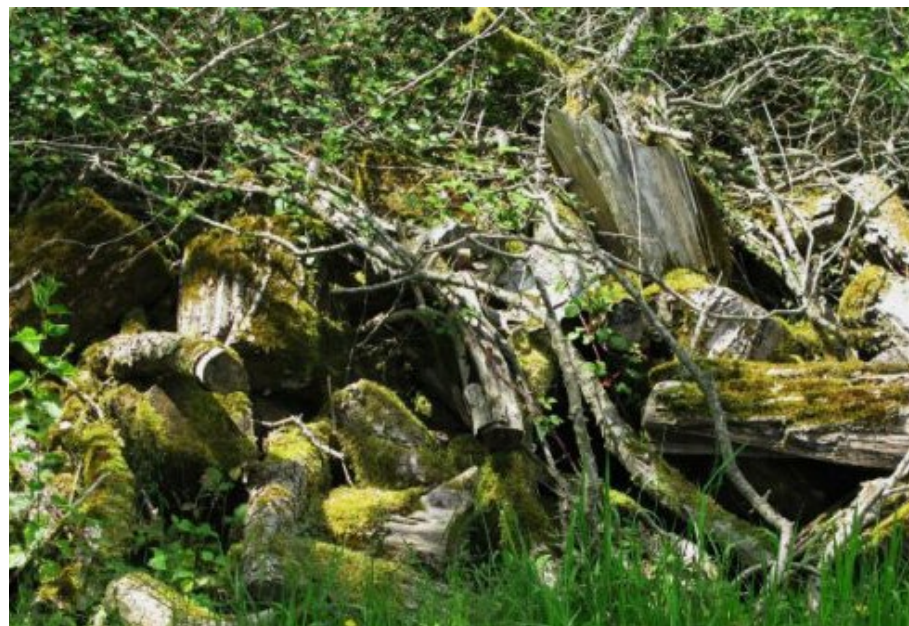
Deadwood log piles can be located elsewhere on site to repurpose the removed vegetation and provide new habitat for wildlife

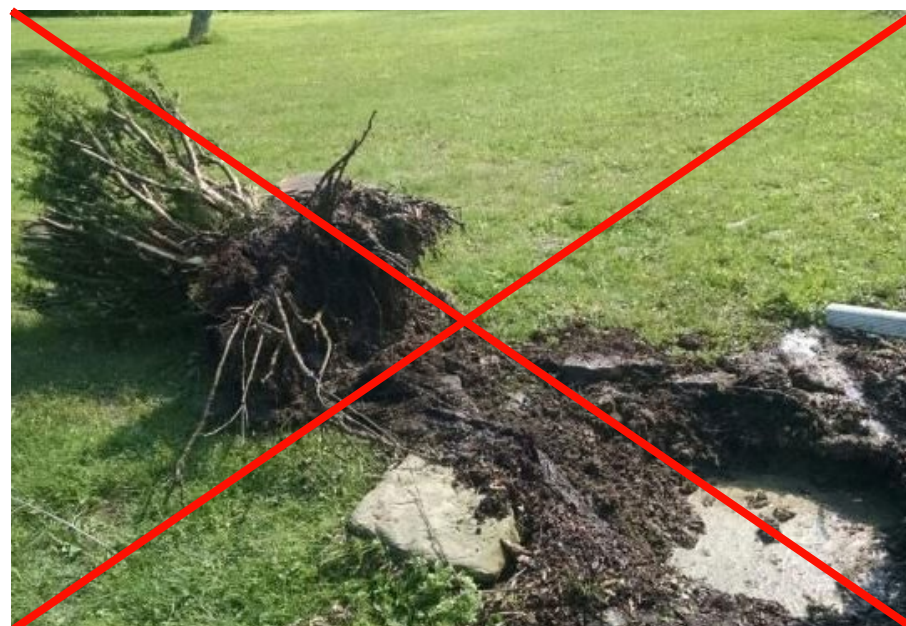
Shrubs should not be pulled out of the ground - they should be cut off at ground level, using hand tools whenever feasible

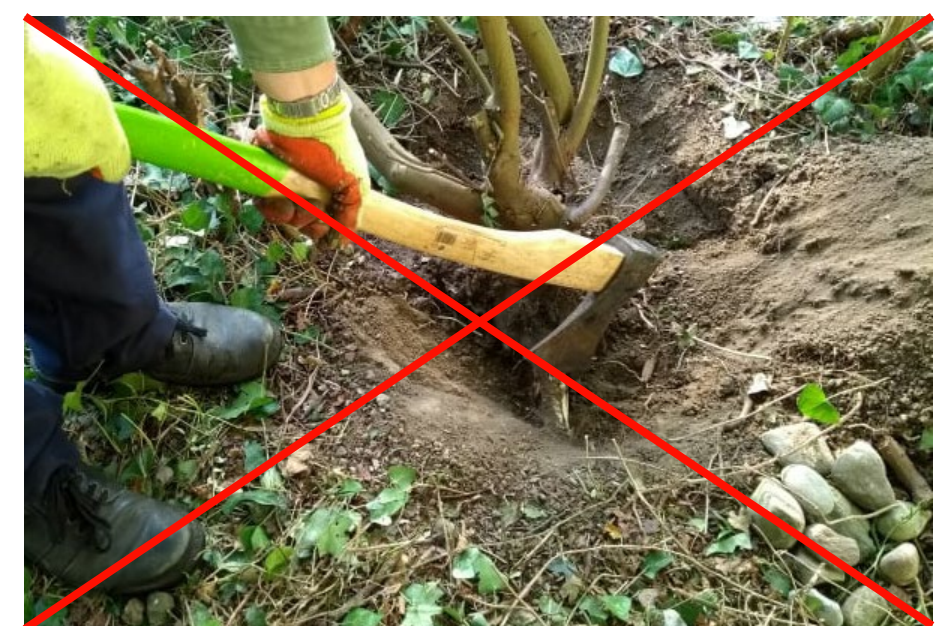
The ground must not be damaged during works

It is important to NOT damage the surface of the ground during removal of vegetation. Avoid the following:

- Digging into the ground to remove stumps or roots
- Using any tools to puncture or chop at the ground surface or vegetation near the ground
- Pulling out shrubs by mechanical or physical means, which could damage the monument as well as leaving a hole

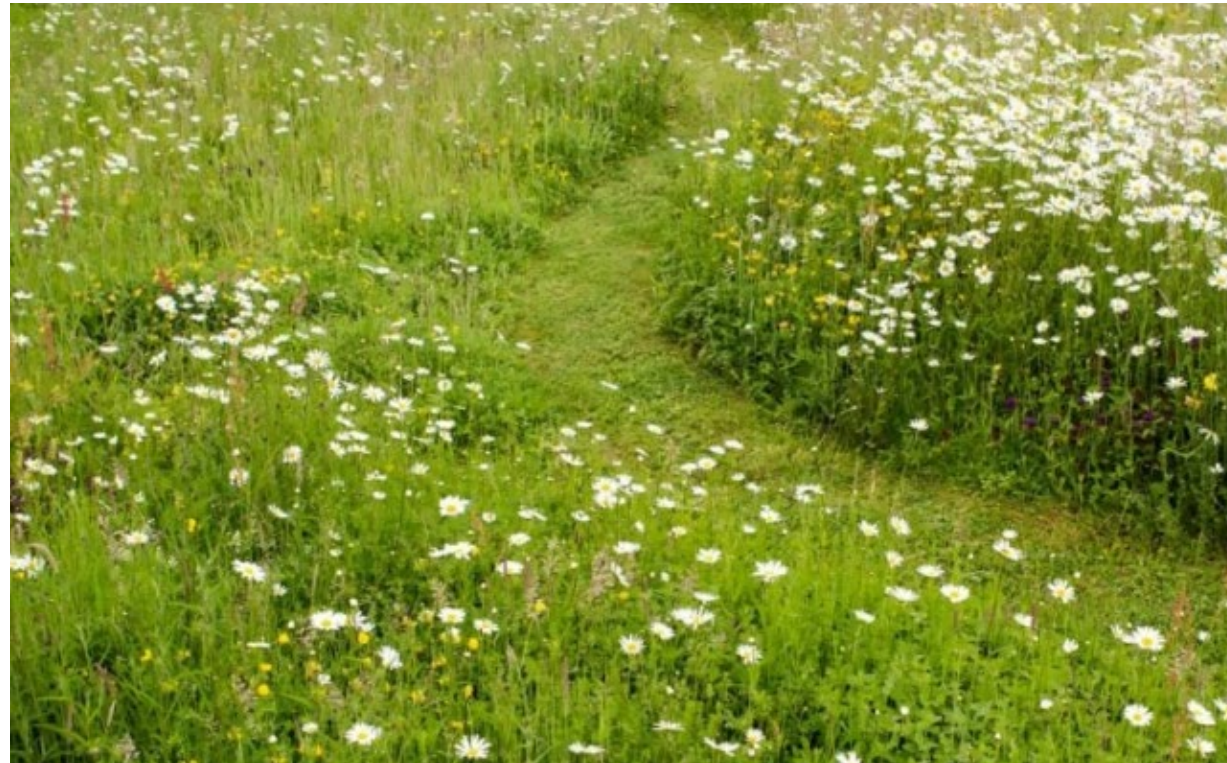
EL1 Flowering Lawn Mixture can be mown or left to grow, and adds biodiversity value even when mown.

- For autumn-sown grass, no further mowing is usually necessary until the following spring
- For spring-sown grass, cut the grass fortnightly, progressively lowering the height of the blades until they're no higher than 50mm. In hot weather, keep the blades high and during drought periods stop mowing altogether

- Remove perennial weeds such as dock with careful application of horticultural vinegar or similar approved organic herbicide
